Designated Substance Survey

Highway 401 Improvements From 1 km East of Highway 16 to 3.3 km West of Maitland Road, Preliminary Design and Class Environmental Assessment Study – G.W.P. 4024-20-00

Ministry of Transportation, Eastern Region, Ontario

May 2022

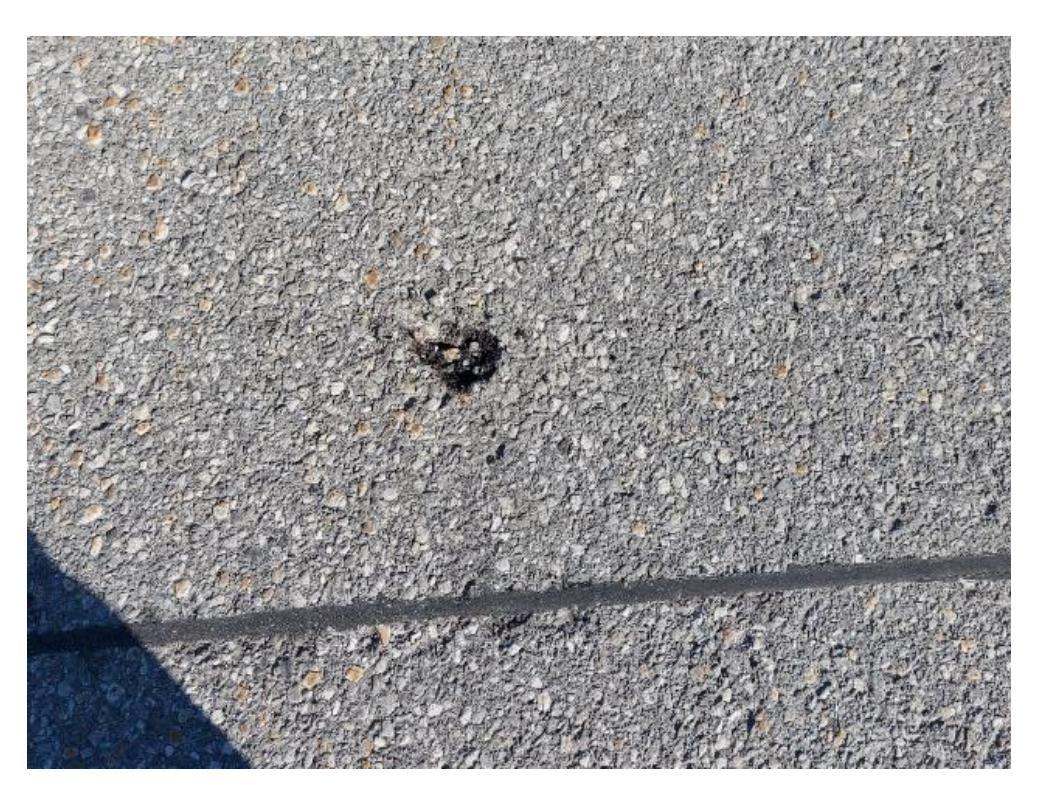
Photograph 5: Bridge No. 16-126 – Highway 401 Maitland Road Interchange. View of bulk asphalt sample 16-126-ASP-01A along top side of the bridge. All bulk samples collected from the Site found not to contain asbestos.

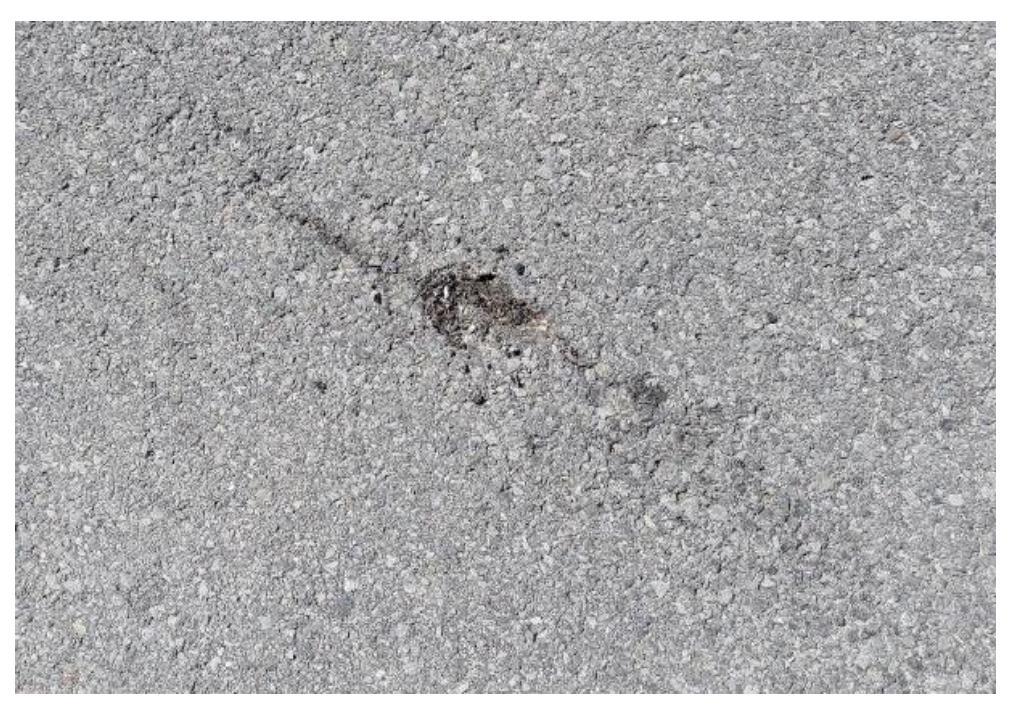
Photograph 10: Bridge No. 16-165 – Highway 401 Blue Church Road Underpass. View of bulk asphalt sample 16-165-ASP-01A along top side of the bridge. All bulk samples collected from the Site found not to contain asbestos.

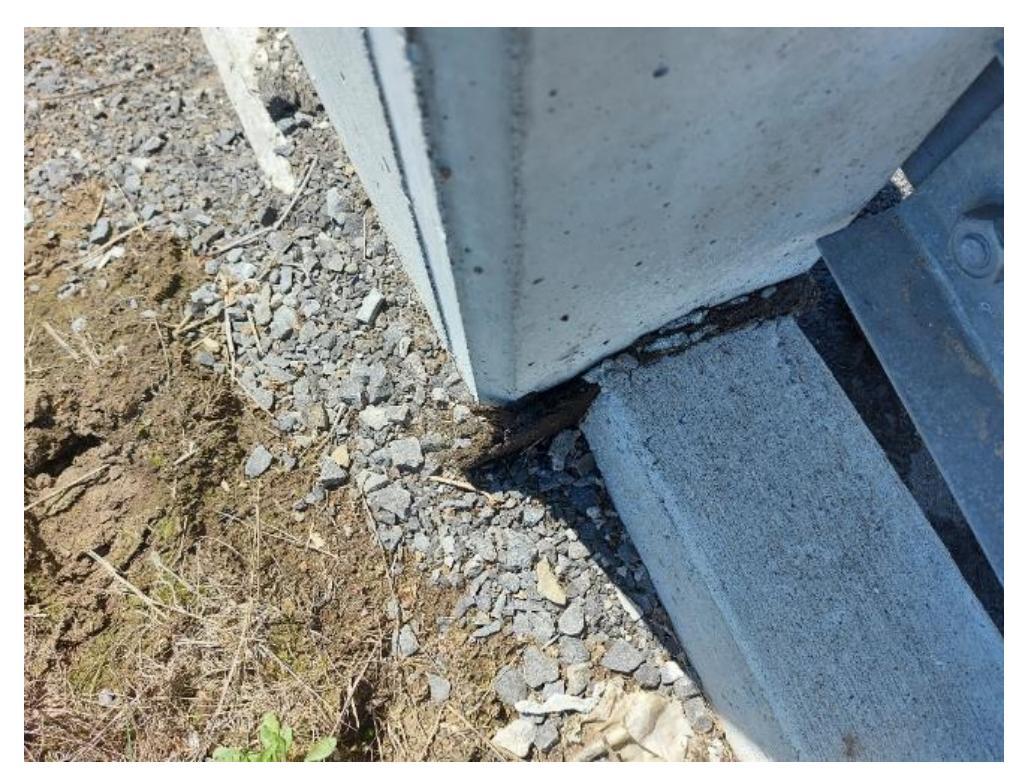
Photograph 11: Bridge No. 16-165 – Highway 401 Blue Church Road Underpass. View of bridge bulk paper insulation sample 16-165-PR-01A. All bulk samples collected from the Site found not to contain asbestos.

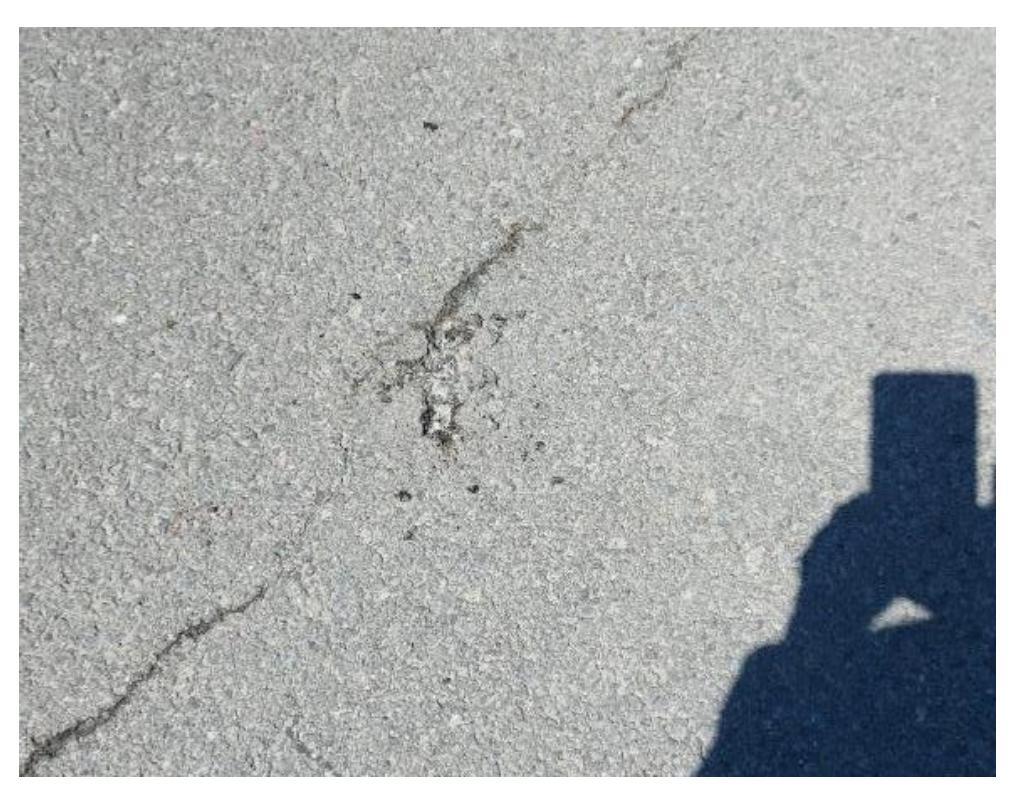
Photograph 16: Bridge No. 16-166 – Highway 401 Merwin Lane Underpass. View of bulk asphalt sample 16-166-ASP-01A along top side of the bridge. All bulk samples collected from the Site found not to contain asbestos.

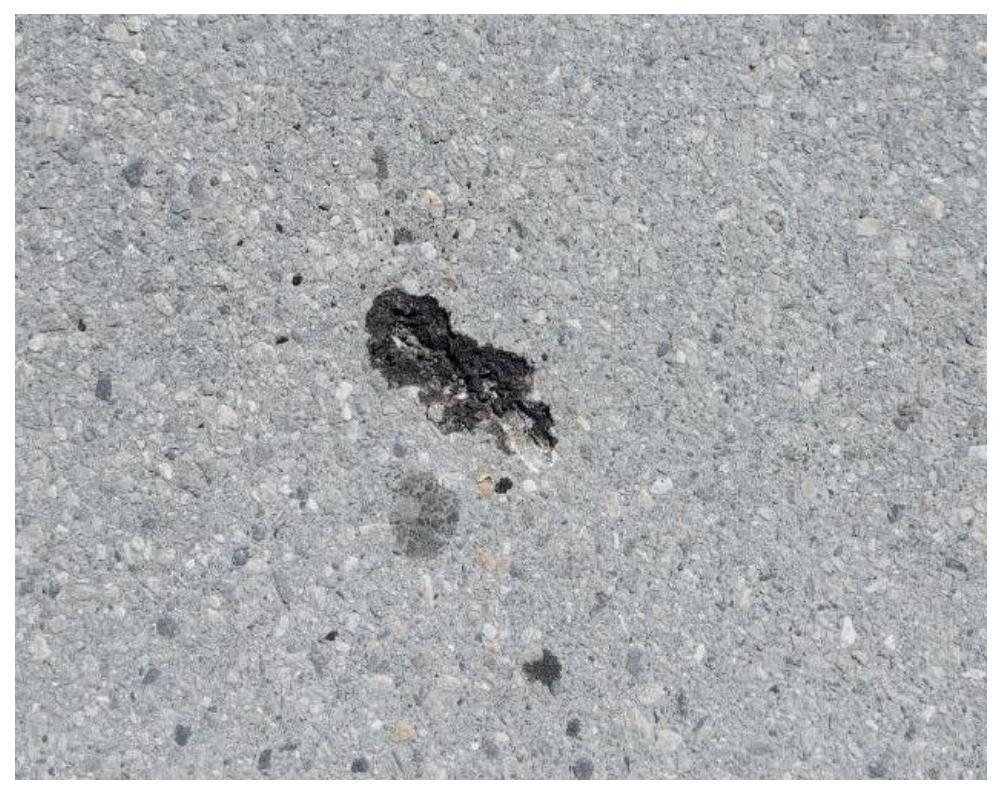
Photograph 22: Bridge No. 16-128 – Highway 401 Edward Street Interchange. View of bulk asphalt sample 16-128-ASP-01A along top side of the bridge. All bulk samples collected from the Site found not to contain asbestos.

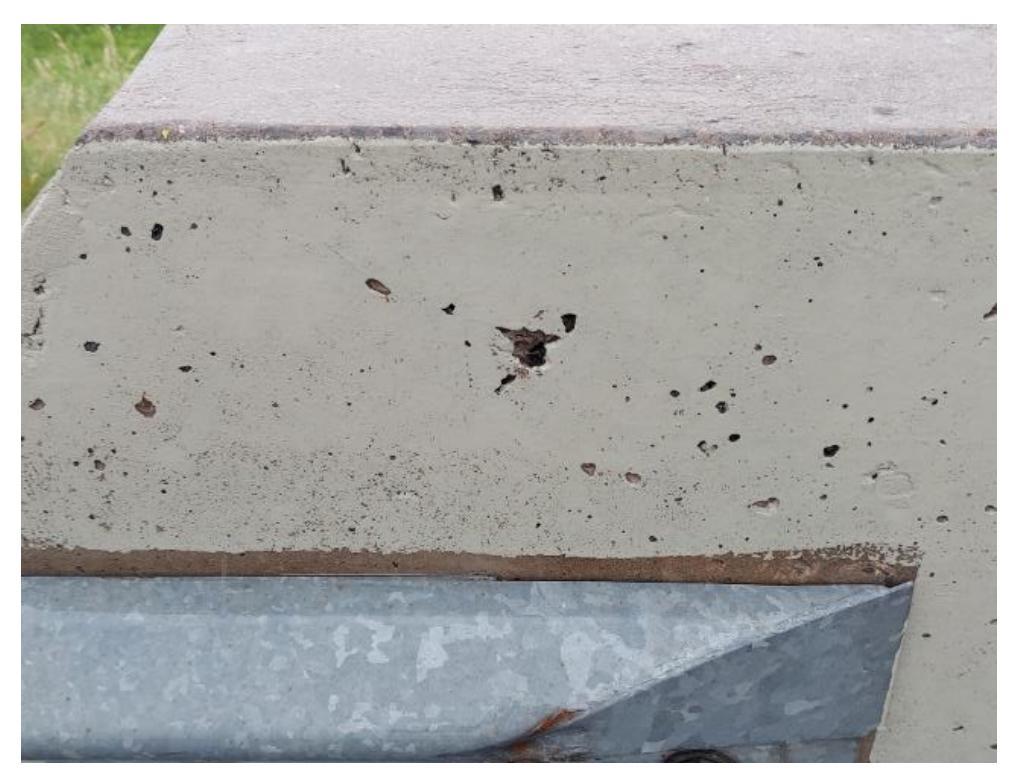
Photograph 26: Bridge No. 16-129 – Highway 401 CPR Overhead. View of paint sample from concrete barrier wall along the south side of the bridge. Paint sample 16-129-PT-01 contained <10 ppm of lead.

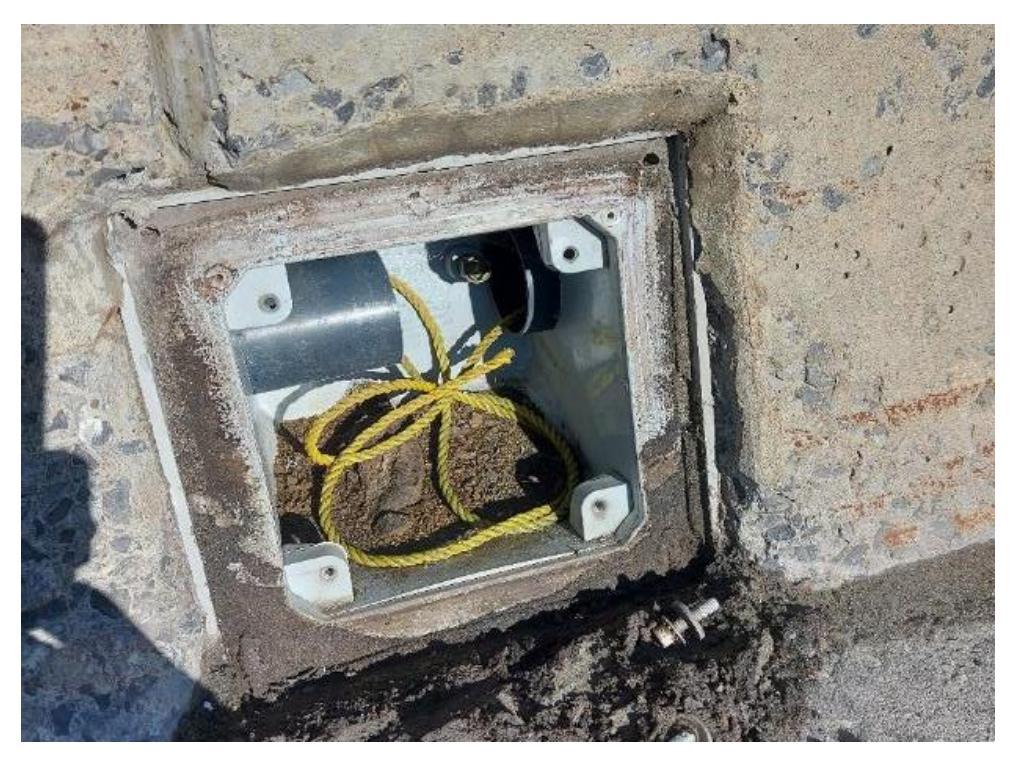
Photograph 30: Bridge No. 16-307 – Highway 401 Cedar Grove Road Overpass. View of conduit hatch with PVC piping along the east side of the bridge. The hatch did not contain any electrical wiring.

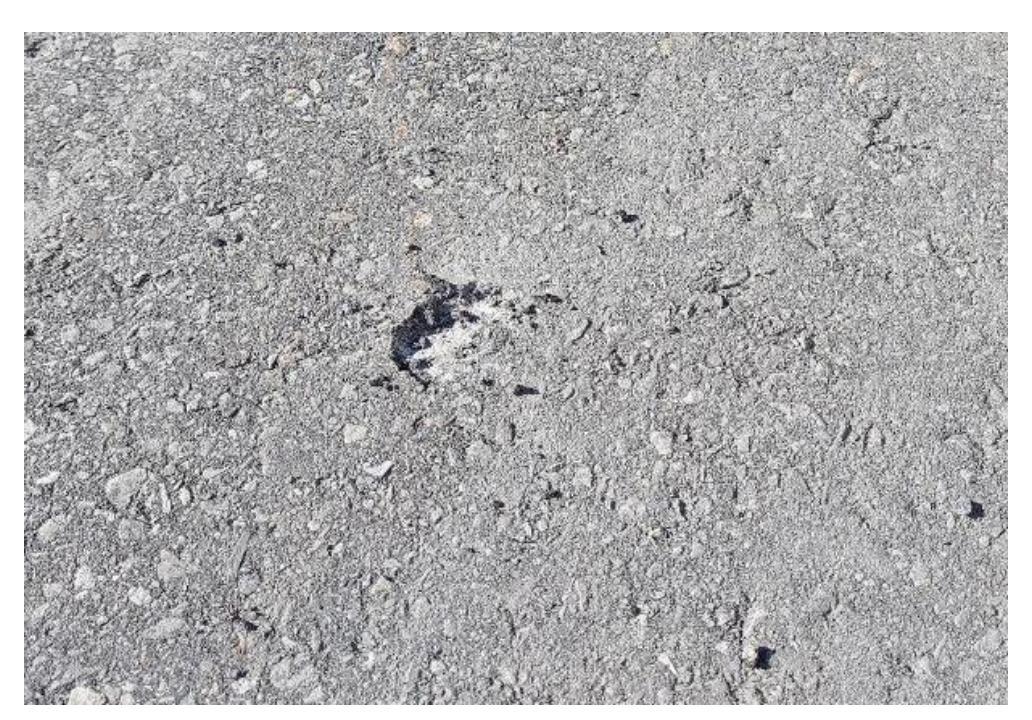
Photograph 31: Bridge No. 16-307 – Highway 401 Cedar Grove Road Overpass. View of bulk asphalt sample 16-307-ASP-01A along top side of the bridge. All bulk samples collected from the Site found not to contain asbestos.

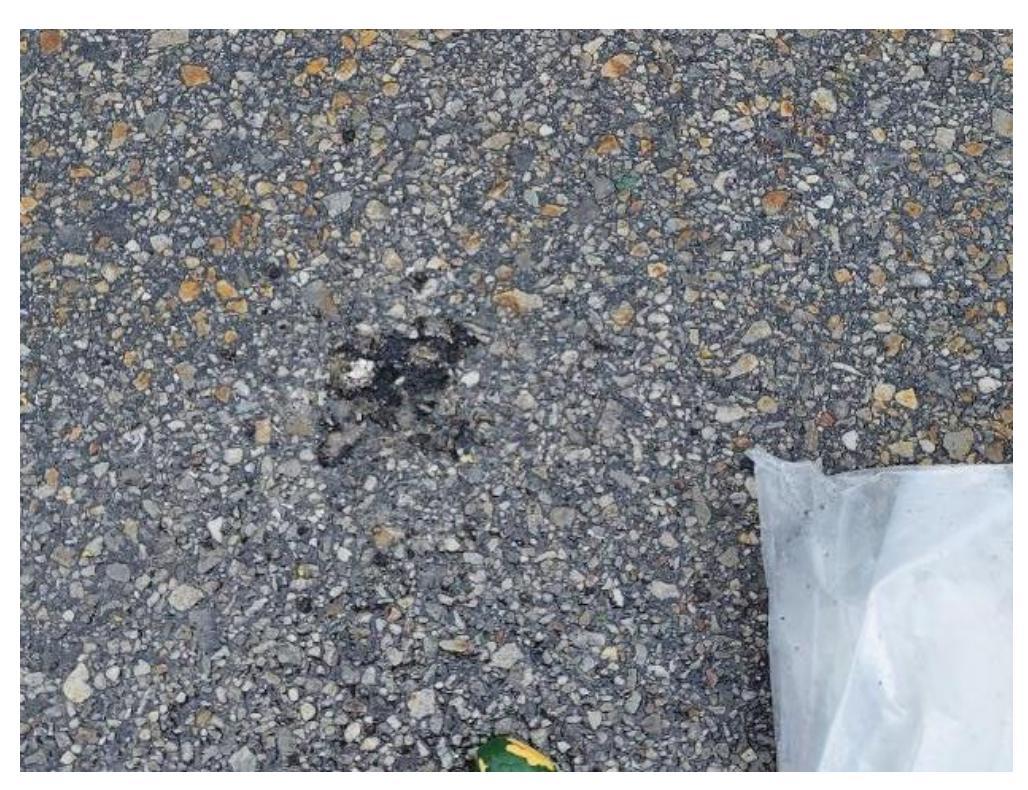
Photograph 37: Bridge No. 16-308 – Highway 401 Southbound Connector N-E. View of bulk asphalt sample 16-308-ASP-01A along top side of the bridge. All bulk samples collected from the Site found not to contain asbestos.

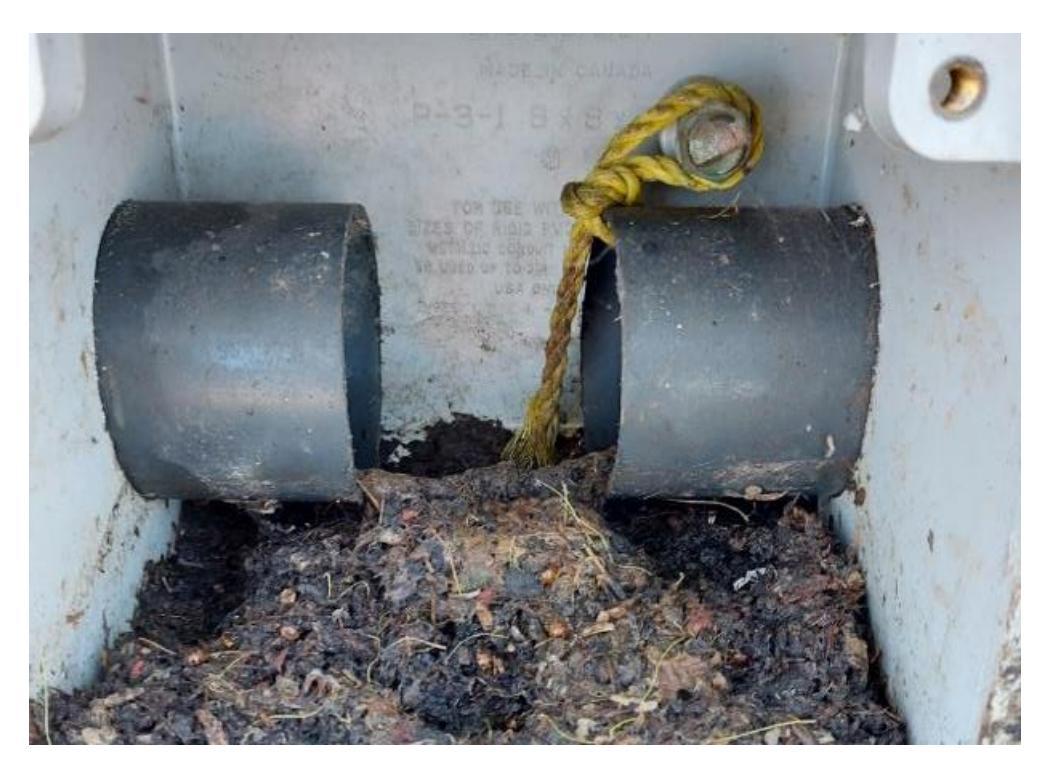
Photograph 41: Bridge No. 16-306 – Highway 401/416 W-N Ramp. View of conduit hatch with PVC piping along the east side of the bridge. The hatch did not contain any electrical wiring.

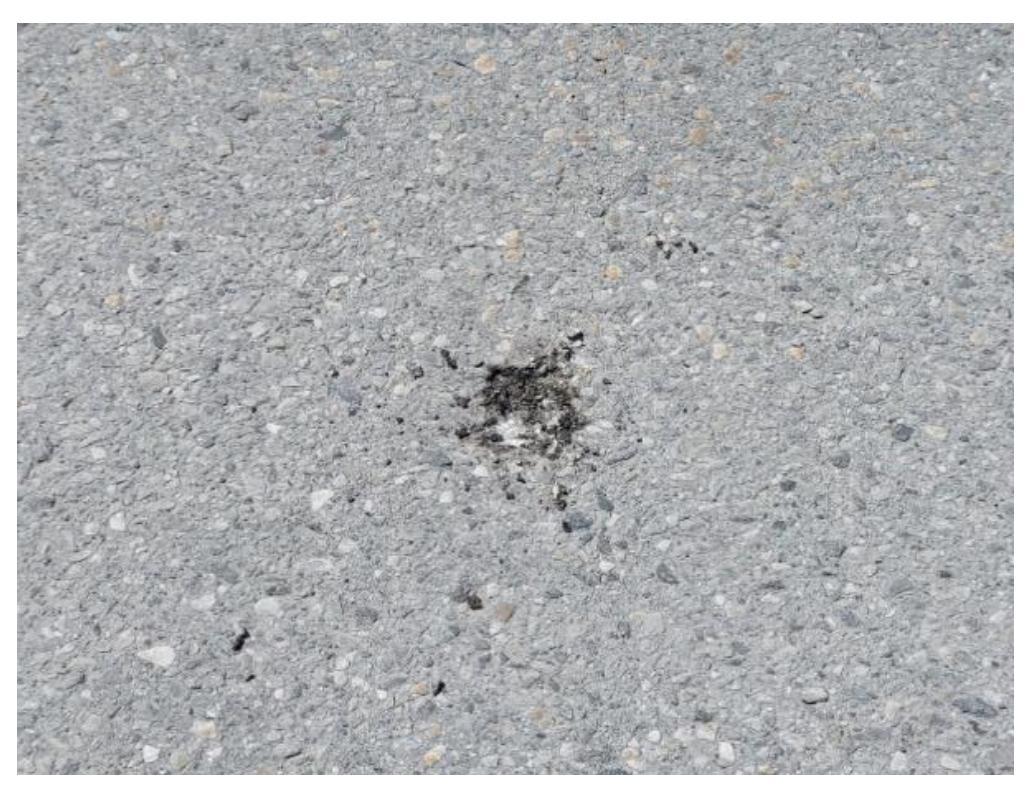
Photograph 42: Bridge No. 16-306 – Highway 401/416 W-N Ramp. View of bulk asphalt sample 16-306-ASP-01A along top side of the bridge. All bulk samples collected from the Site found not to contain asbestos.

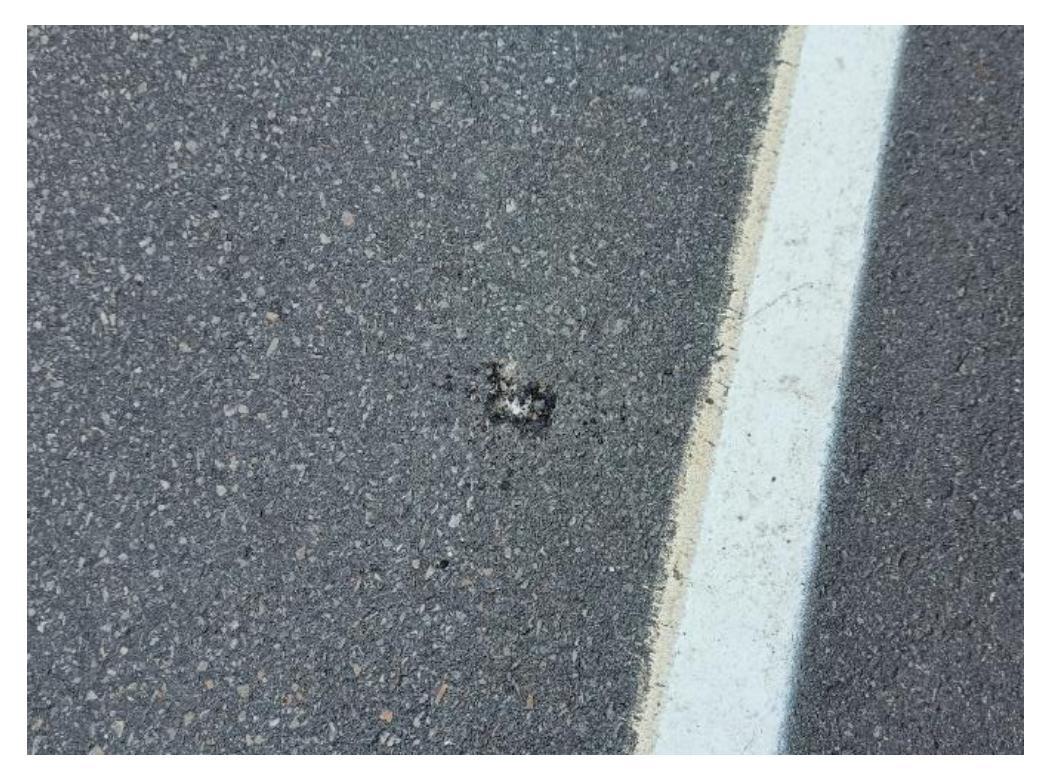
Photograph 46: Bridge No. 16-130-Highway 16 U/P. View of bulk asphalt sample 16-130-ASP-01A along top side of the bridge. All bulk samples collected from the Site found not to contain asbestos.

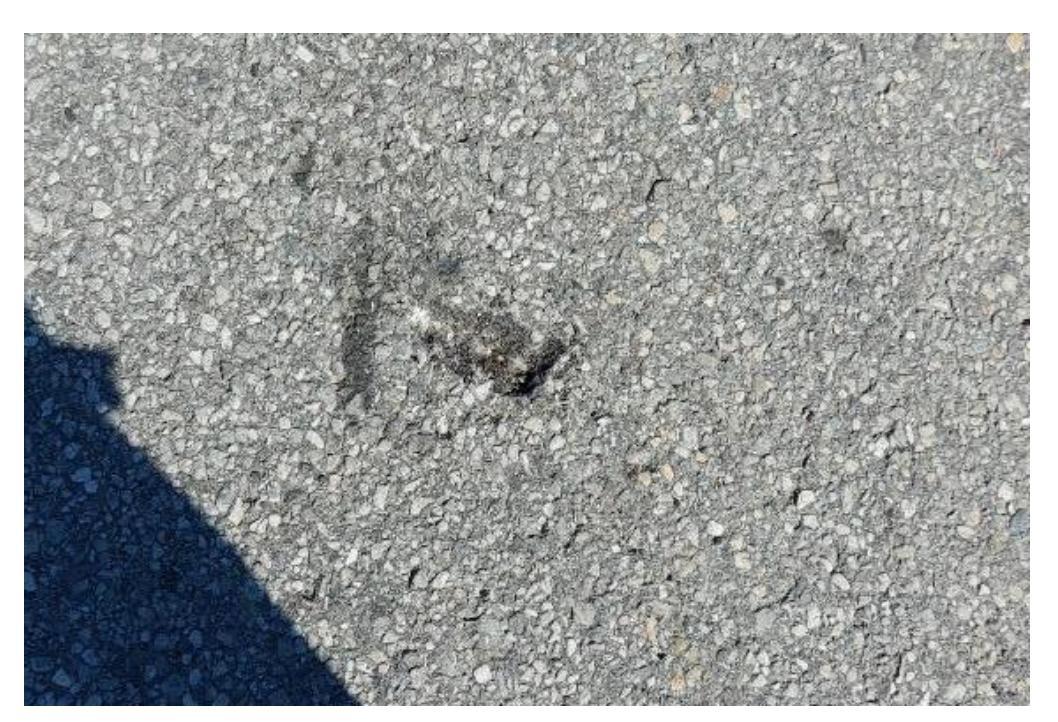
Photograph 51: Bridge No. 16-131 – Highway 16 CNR Overhead. View of bulk asphalt sample 16-131-ASP-01A along top side of the bridge. All bulk samples collected from the Site found not to contain asbestos.

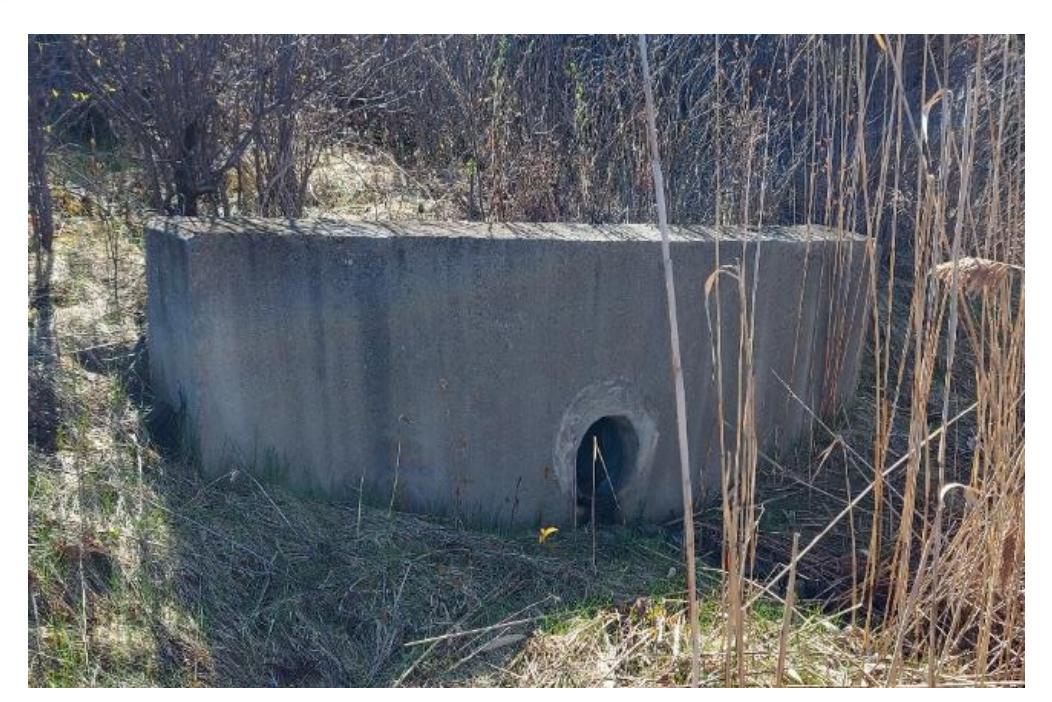
Photograph 61: Additional culvert at Project Site: View of additional culvert located along the north side of Highway 416 south abutment immediately west of culvert 16-259. The south portion of the additional culvert could not be located by AECOM. Culvert was not stamped with any identification or construction date.

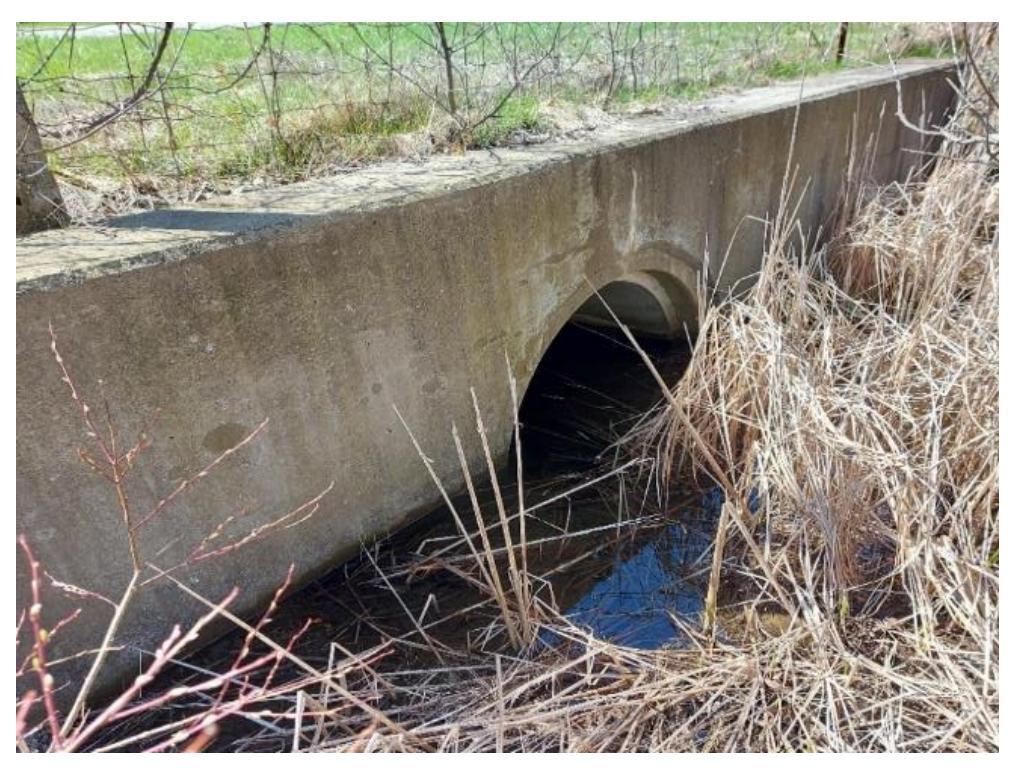
Photograph 63: Additional culvert at Project Site: View of additional culvert located along the north side of Cedar Grove Road east of the bridge Site 16-307. Culvert was not stamped with any identification or construction date.

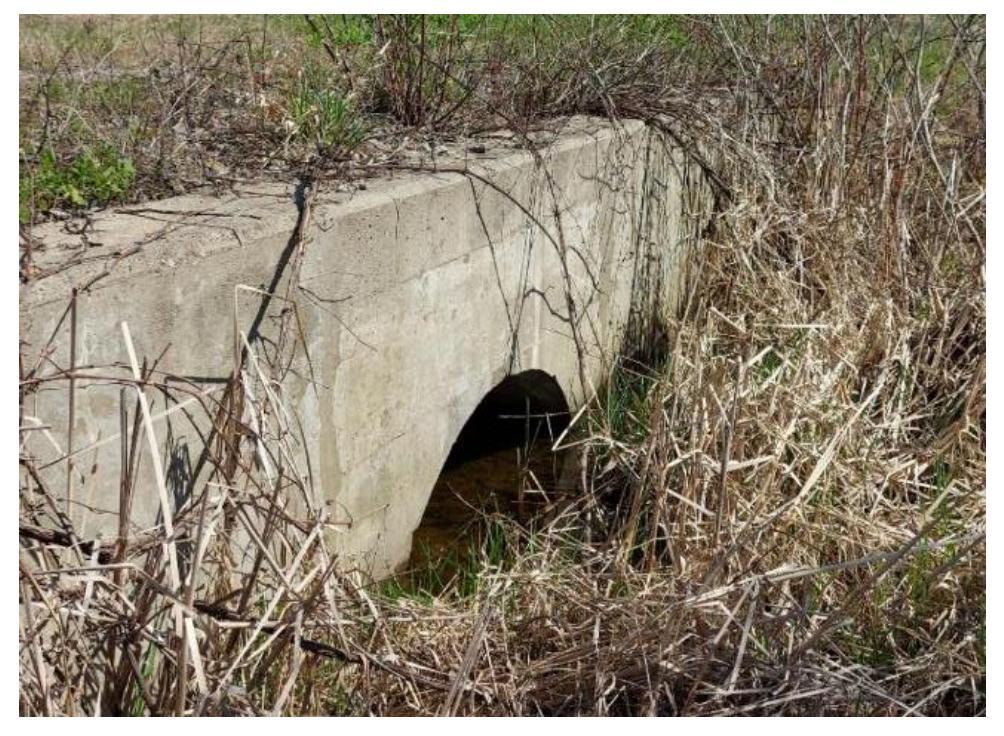
Photograph 64: Additional culvert at Project Site: View of additional culvert located along the south side of Cedar Grove Road east of the bridge Site 16-307. Culvert was not stamped with any identification or construction date.
