Designated Substance Survey

Highway 401 Improvements From 1 km East of Highway 16 to 3.3 km West of Maitland Road, Preliminary Design and Class Environmental Assessment Study – G.W.P. 4024-20-00

Ministry of Transportation, Eastern Region, Ontario

May 2022

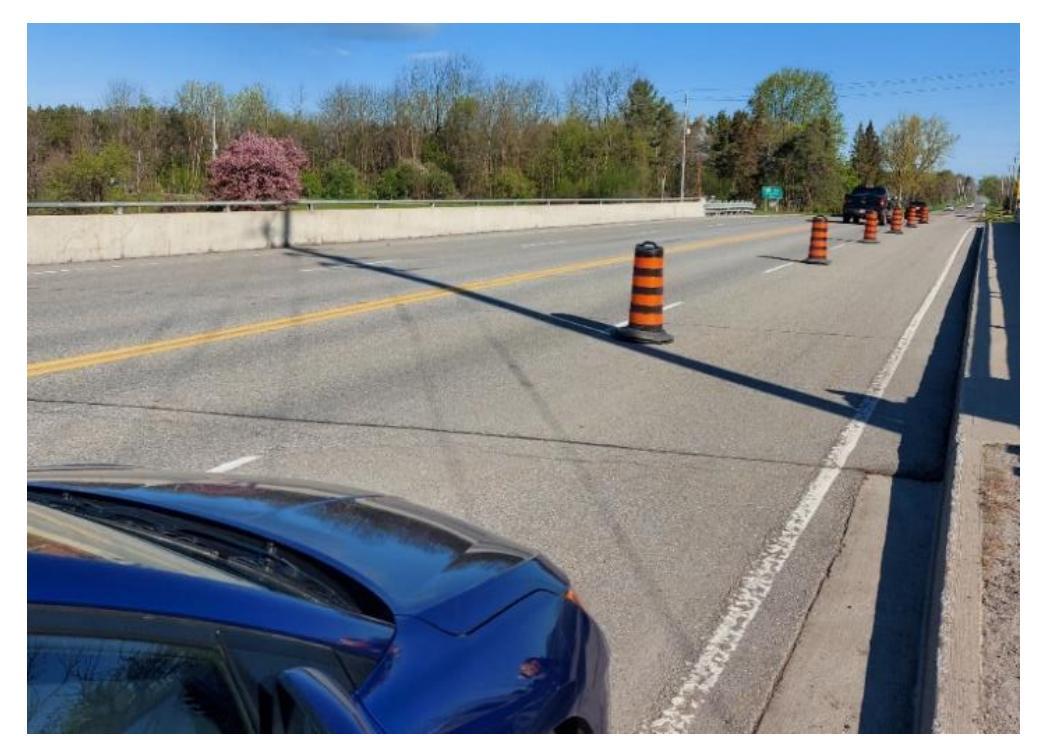
Photograph 1: Bridge No. 16-126 – Highway 401 Maitland Road Interchange. General view looking north along the bridge.

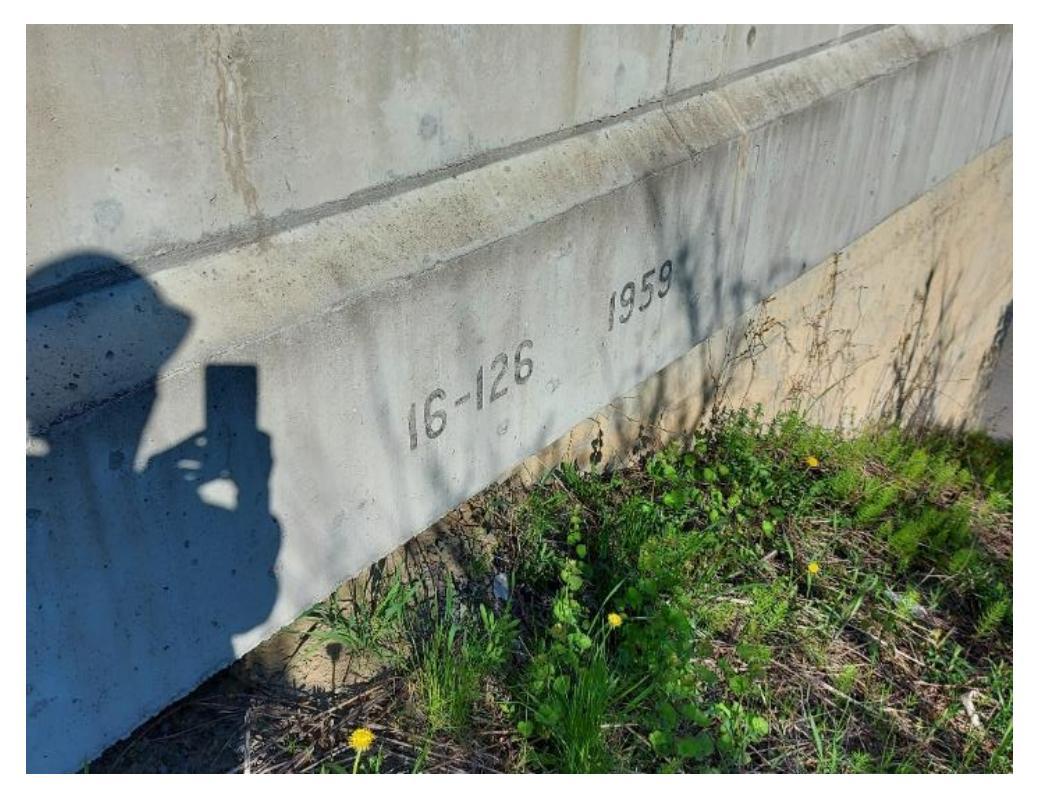
Photograph 2: Bridge No. 16-126 – Highway 401 Maitland Road Interchange. View of bridge stamp with construction date along the east side of the bridge. Bridge stamped 16-126-1959.

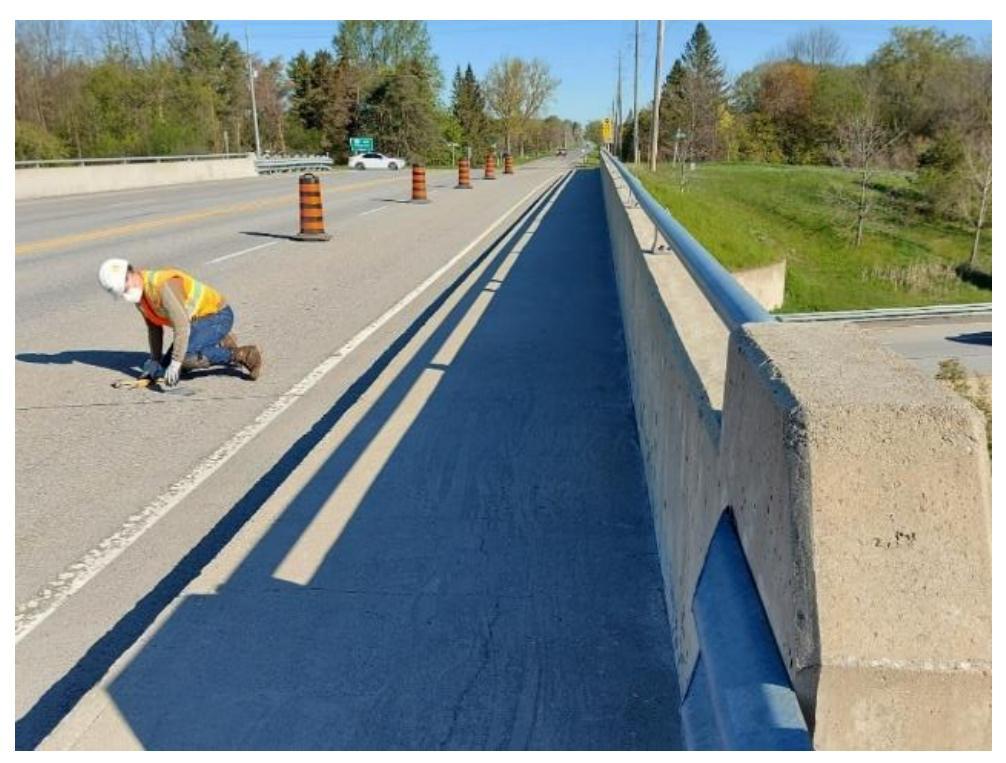
Photograph 3: Bridge No. 16-126 – Highway 401 Maitland Road Interchange. View of concrete barrier wall along the east side of the bridge.

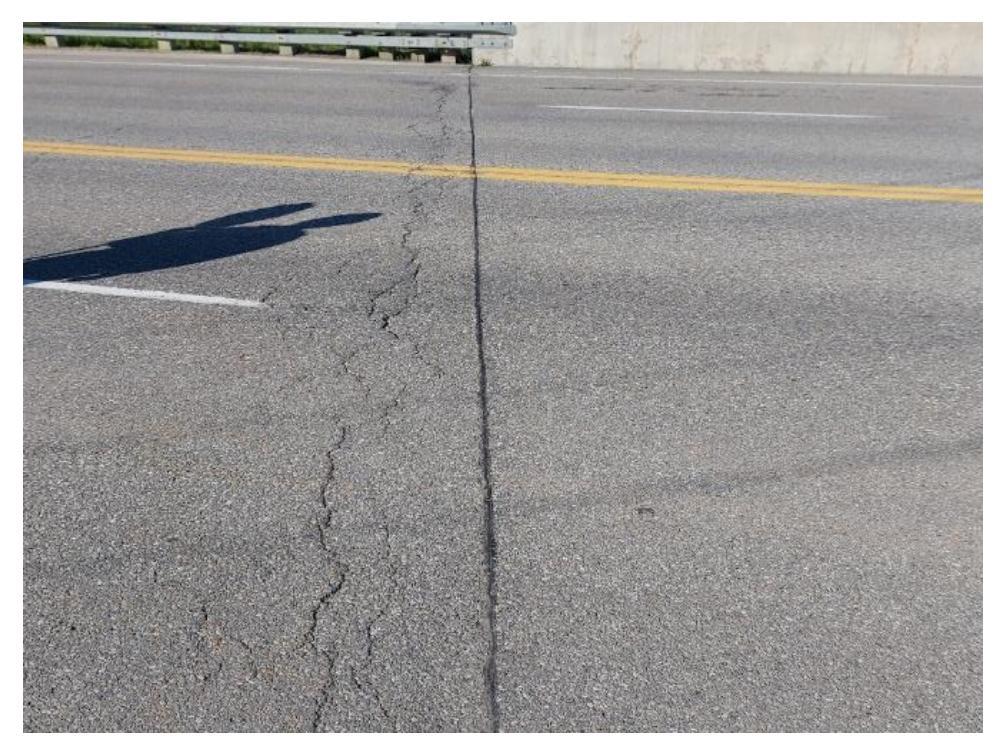
Photograph 4: Bridge No. 16-126 – Highway 401 Maitland Road Interchange. View of bridge boundary along the south side of the bridge.

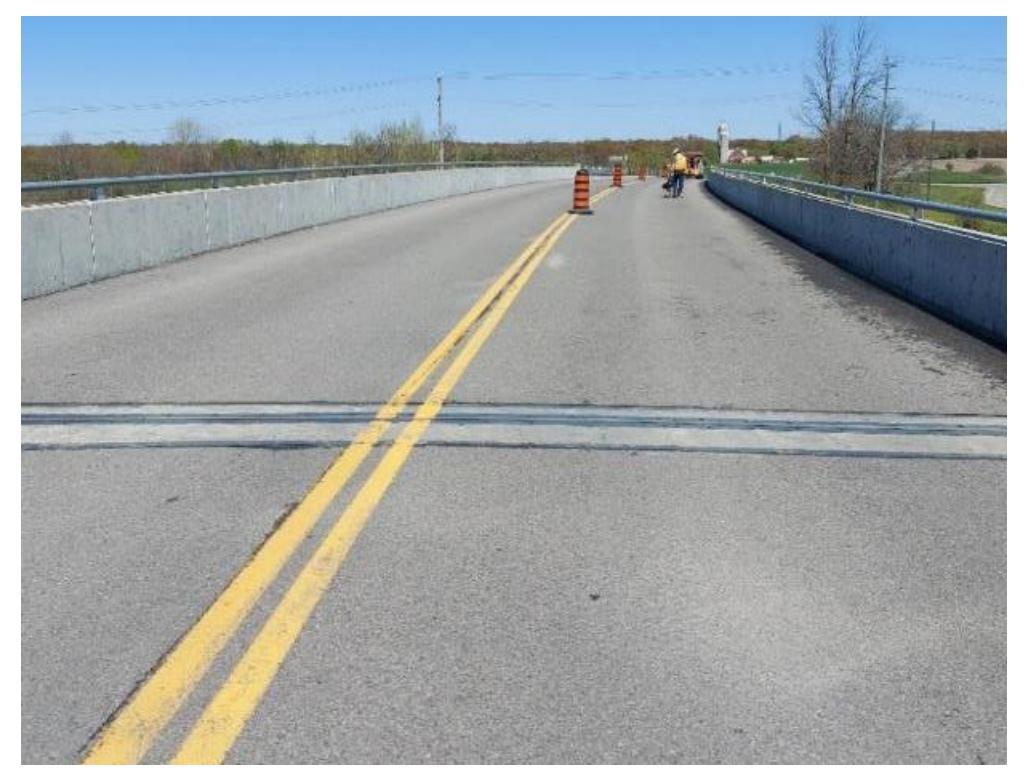
Photograph 6: Bridge No. 16-165 – Highway 401 Blue Church Road Underpass. General view looking north along the bridge.

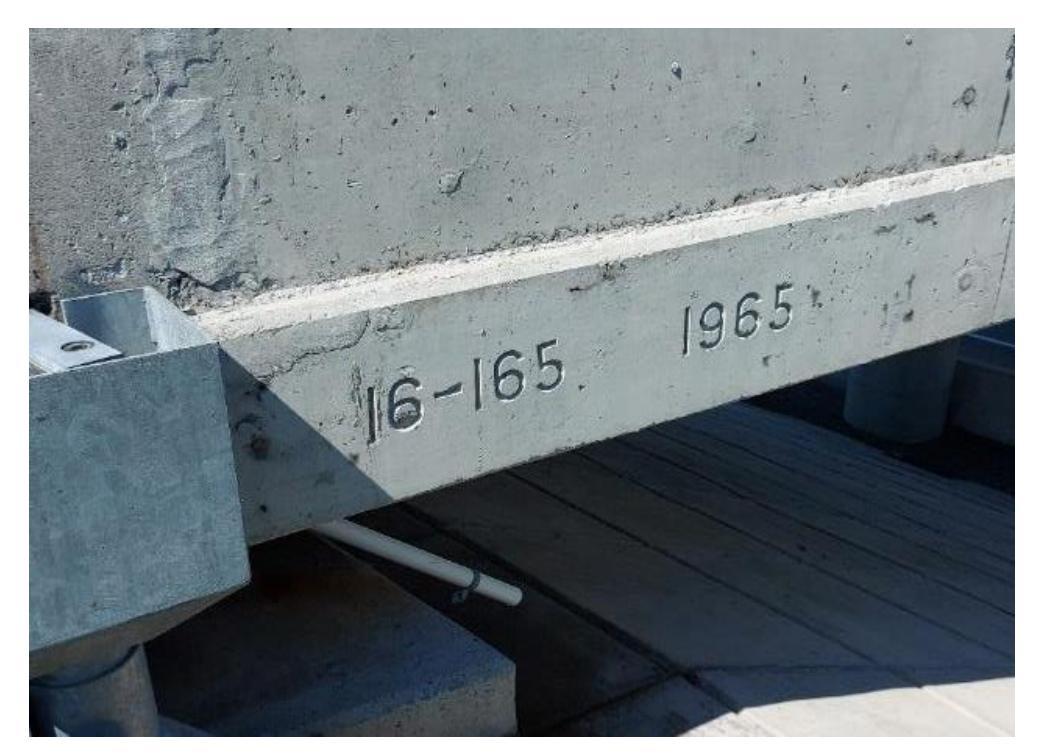
Photograph 7: Bridge No. 16-165 – Highway 401 Blue Church Road Underpass. View of bridge stamp with construction date along the east side of the bridge. Bridge stamped 16-165-1965.

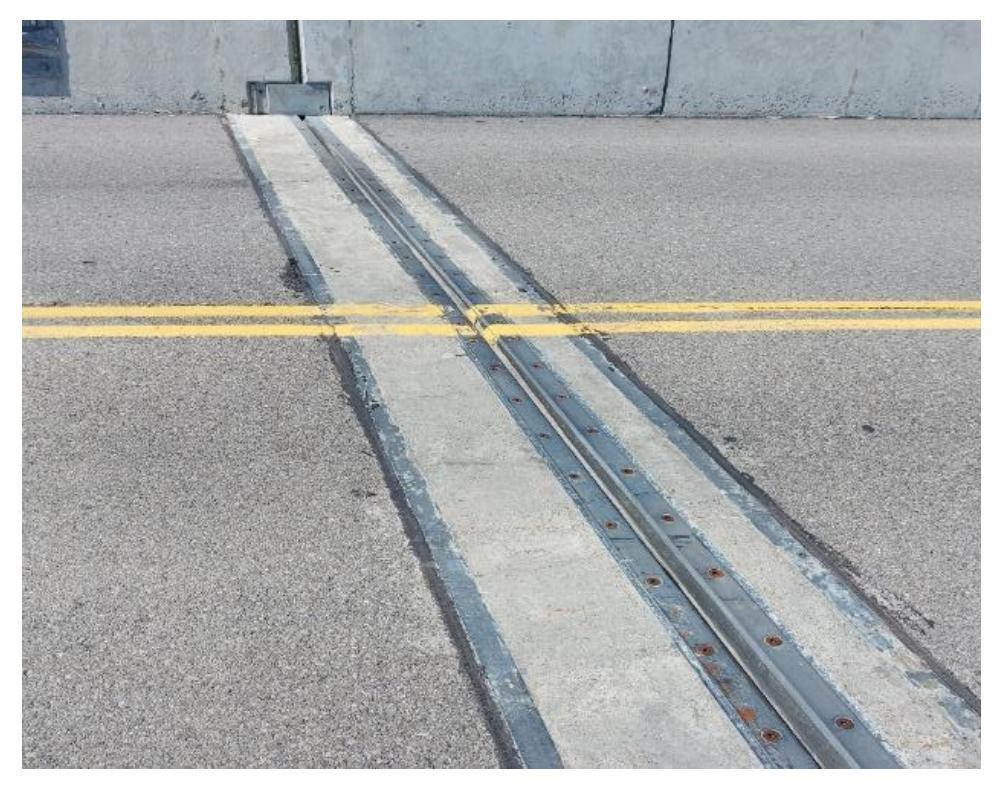
Photograph 8: Bridge No. 16-165 – Highway 401 Blue Church Road Underpass. View of bridge deck expansion joint along the south side of the bridge.

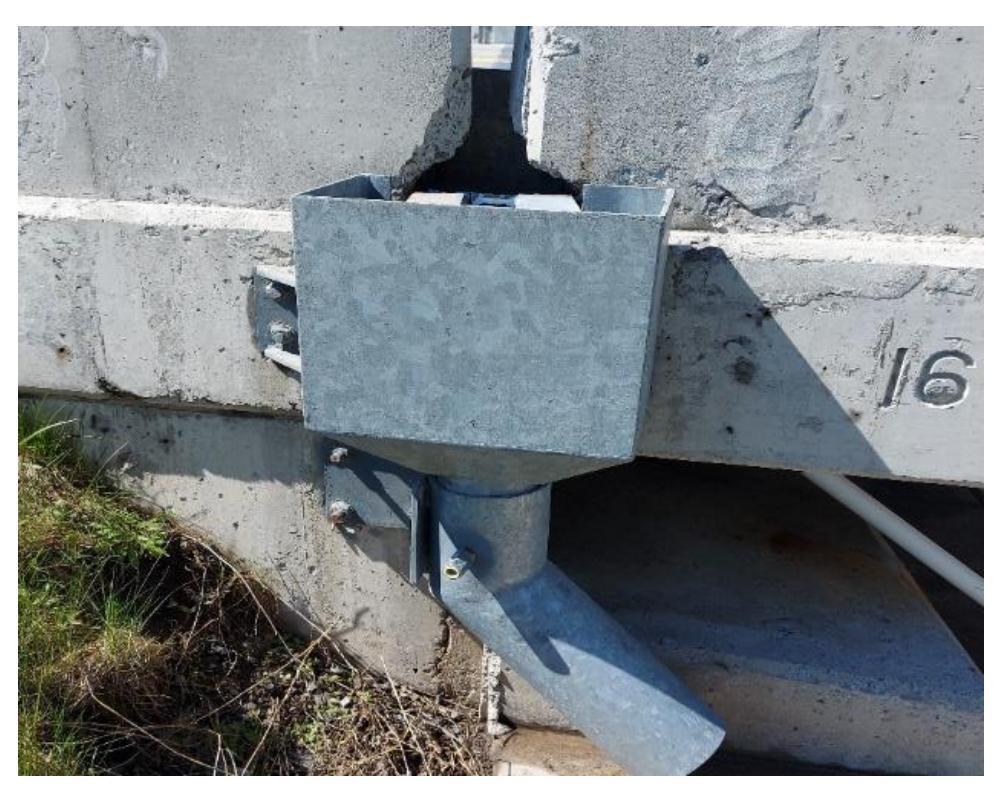
Photograph 9: Bridge No. 16-165 – Highway 401 Blue Church Road Underpass. View of metal surface drain pipe along the east side of the bridge.

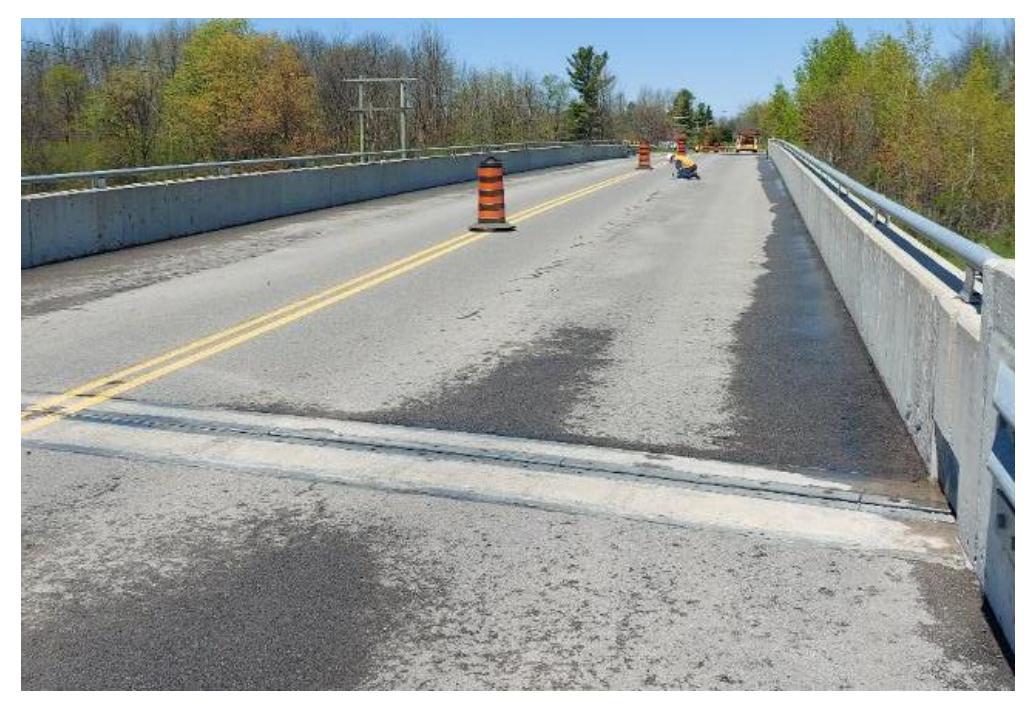
Photograph 12: Bridge No. 16-166 – Highway 401 Merwin Lane Underpass. General view looking north along the bridge.

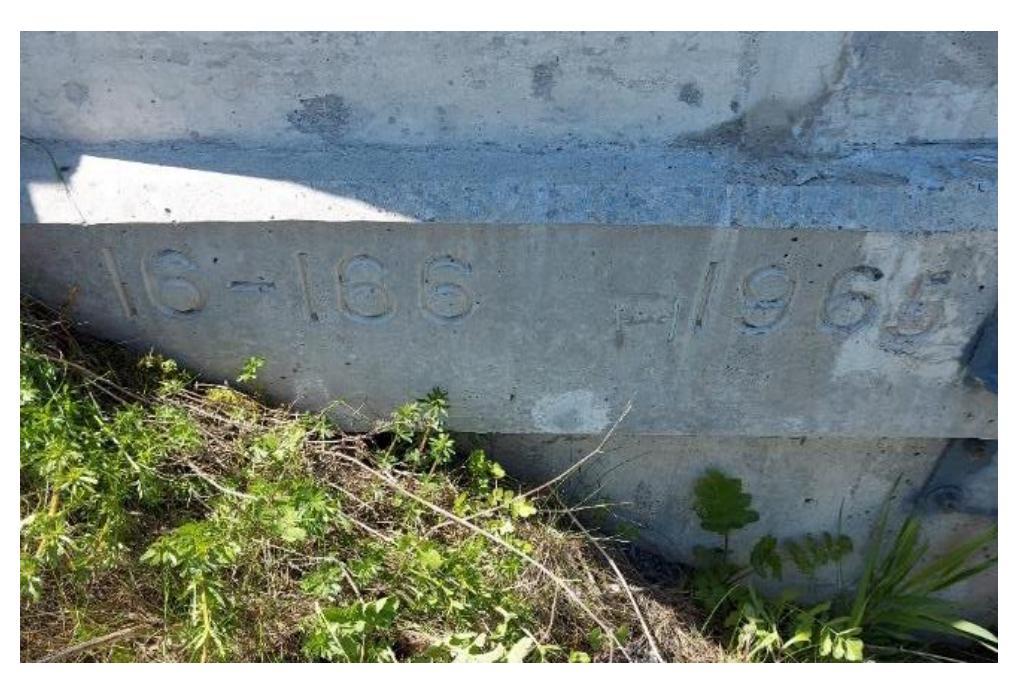
Photograph 13: Bridge No. 16-166 – Highway 401 Merwin Lane Underpass. View of bridge stamp with construction date along the east side of the bridge. Bridge stamped 16-166-1965.

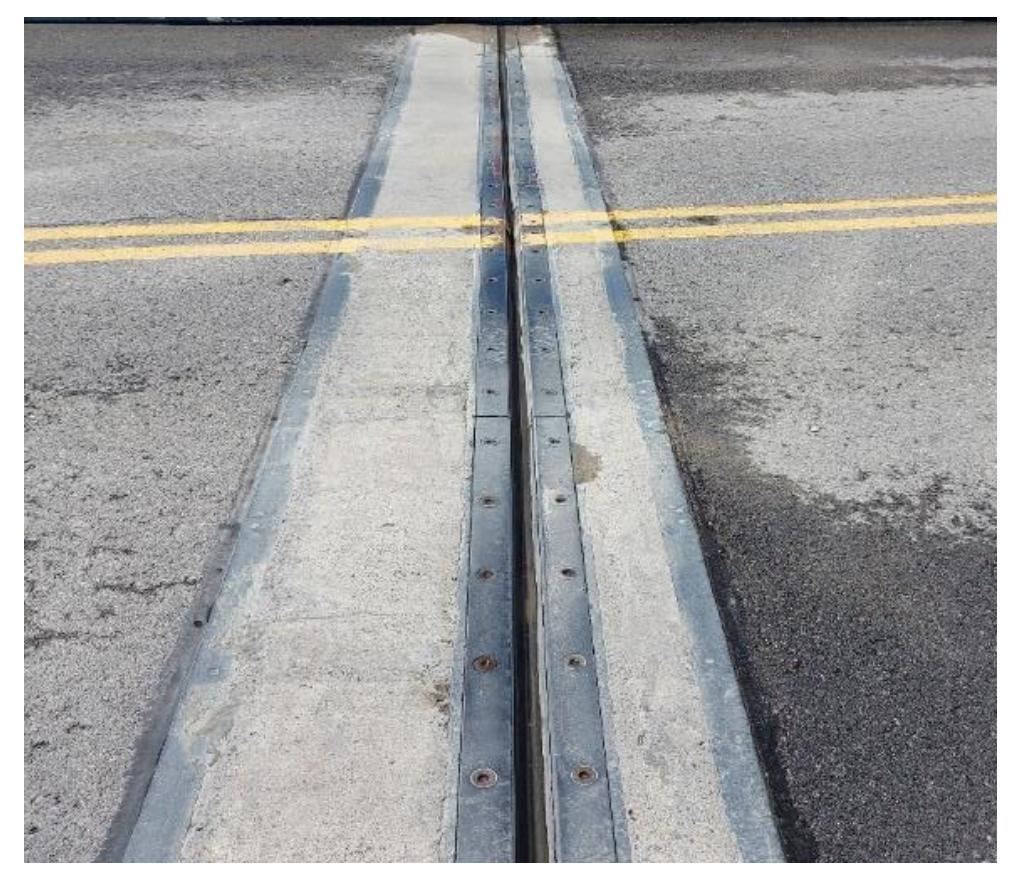
Photograph 14: Bridge No. 16-166 – Highway 401 Merwin Lane Underpass. View of bridge deck expansion joint along the south side of the bridge.

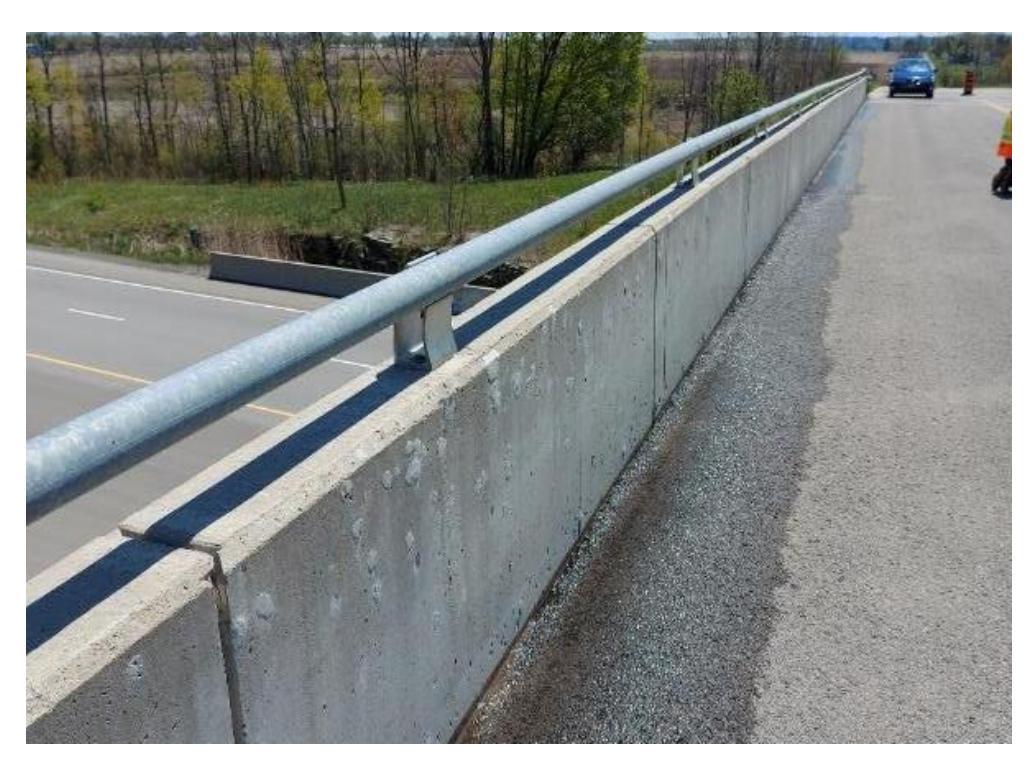
Photograph 15: Bridge No. 16-166 – Highway 401 Merwin Lane Underpass. View of concrete barrier wall with single metal tube railing along the west side of the bridge.

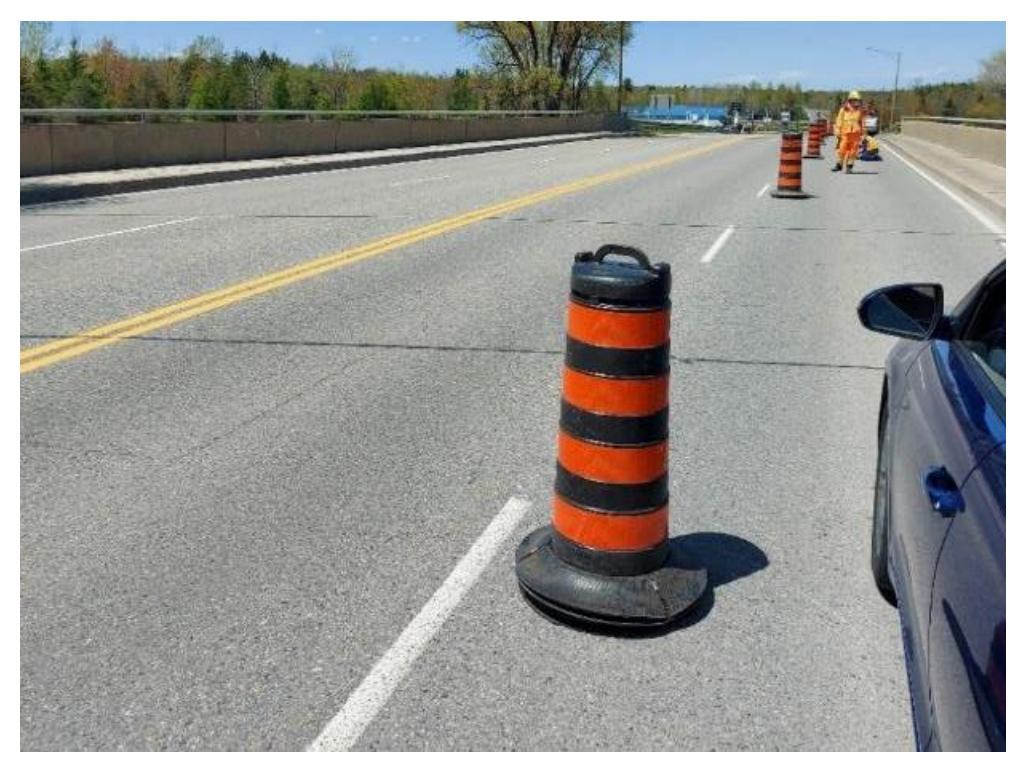
Photograph 17: Bridge No. 16-128 – Highway 401 Edward Street Interchange. General view looking north along the bridge.

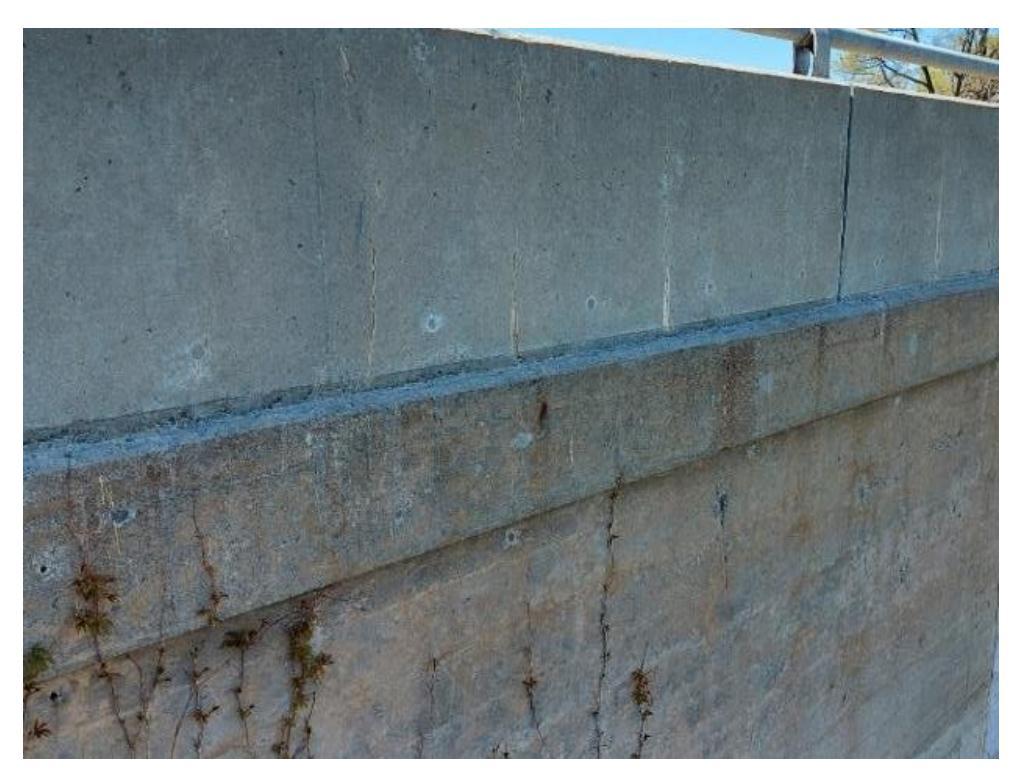
Photograph 18: Bridge No. 16-128 – Highway 401 Edward Street Interchange. View of the east side of the bridge with no date stamp present.

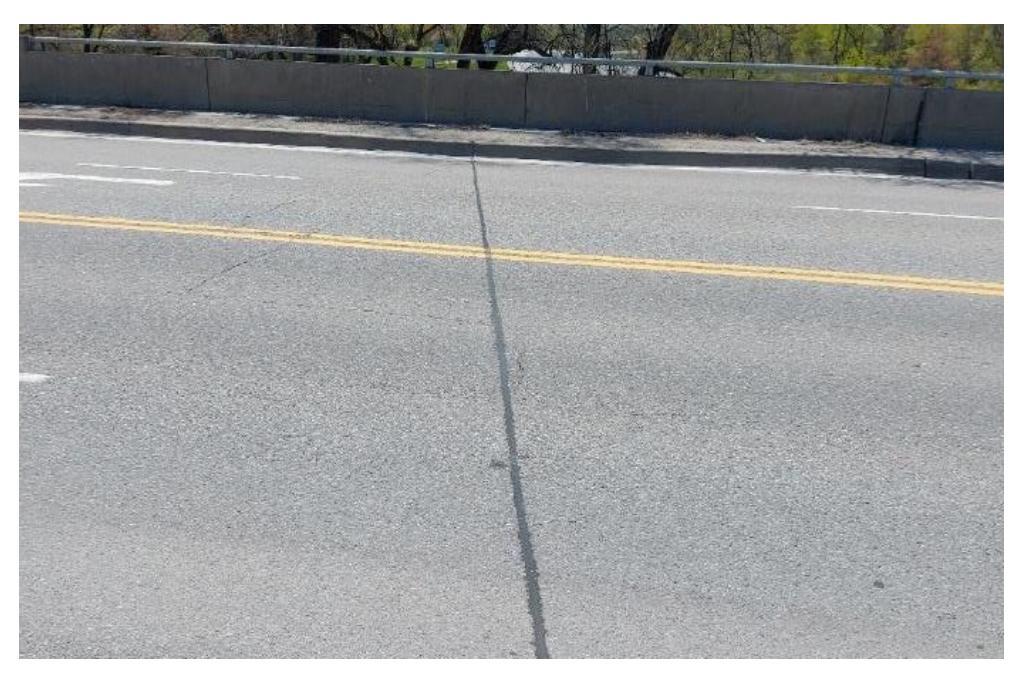
Photograph 19: Bridge No. 16-128 – Highway 401 Edward Street Interchange. View of bridge boundary along the south side of the bridge.

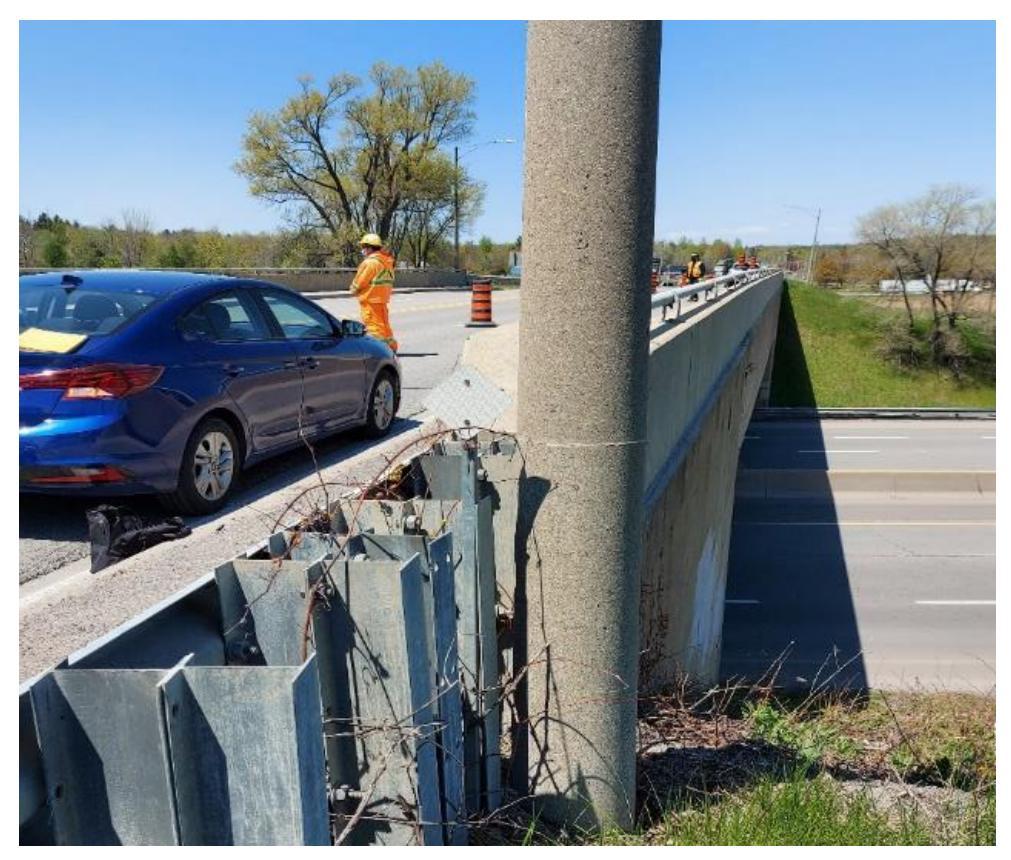
Photograph 20: Bridge No. 16-128 – Highway 401 Edward Street Interchange. View of light pole along southeast area of the bridge Site. Light pole outside of the Site designated substance boundary.

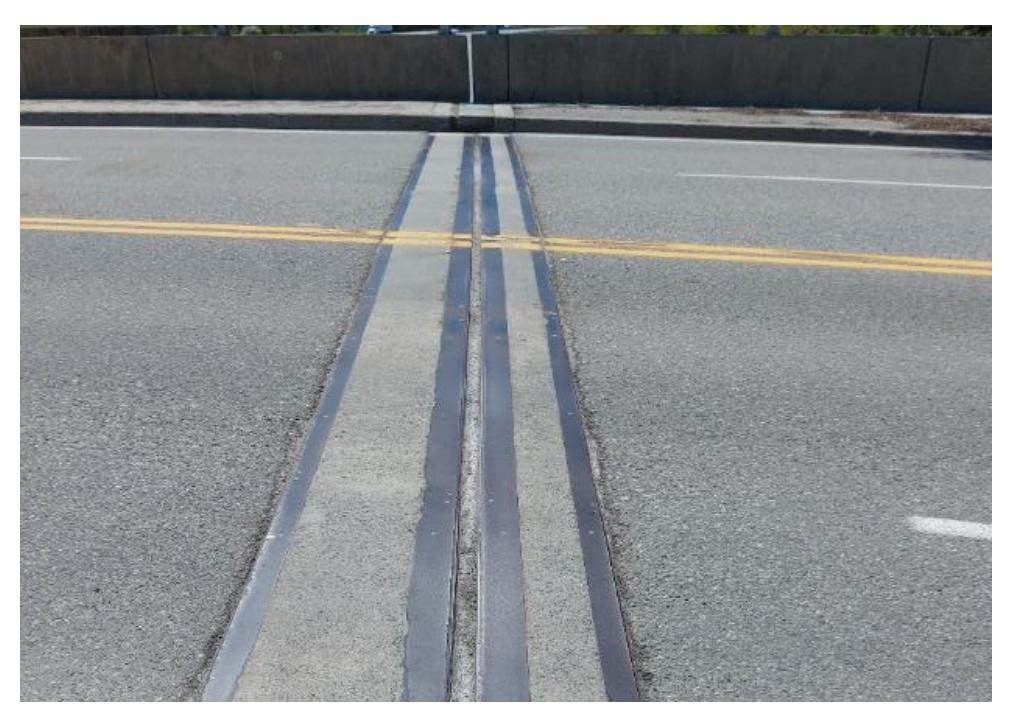
Photograph 21: Bridge No. 16-128 – Highway 401 Edward Street Interchange. View of the bridge deck expansion joint along the north side of the bridge.

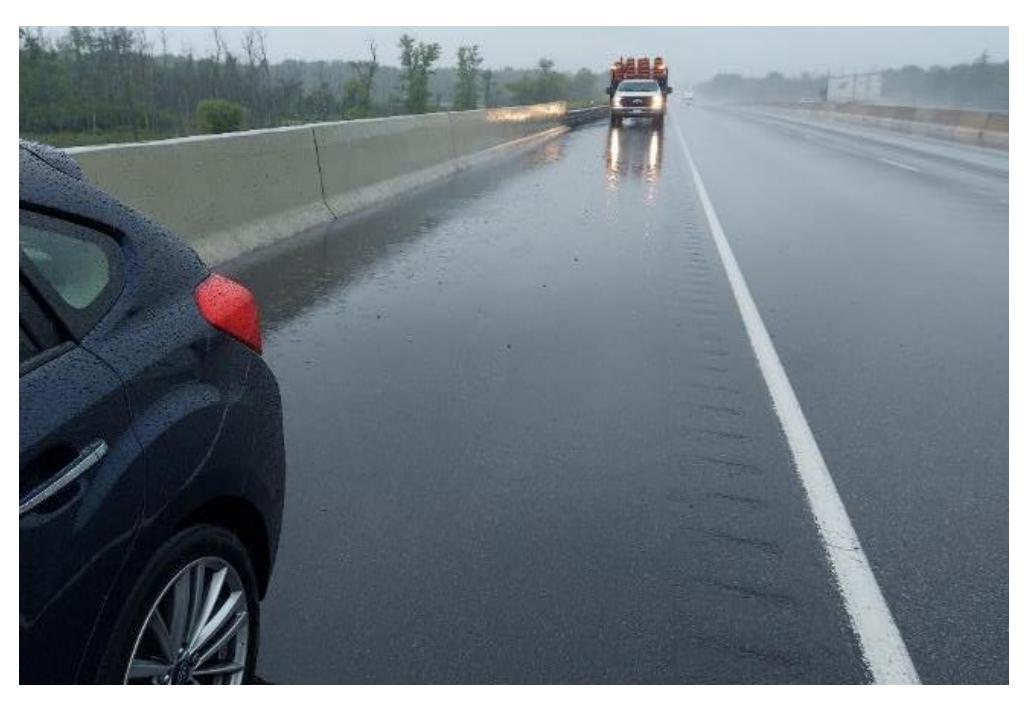
Photograph 23: Bridge No. 16-129 – Highway 401 CPR Overhead. General view looking west along the bridge.

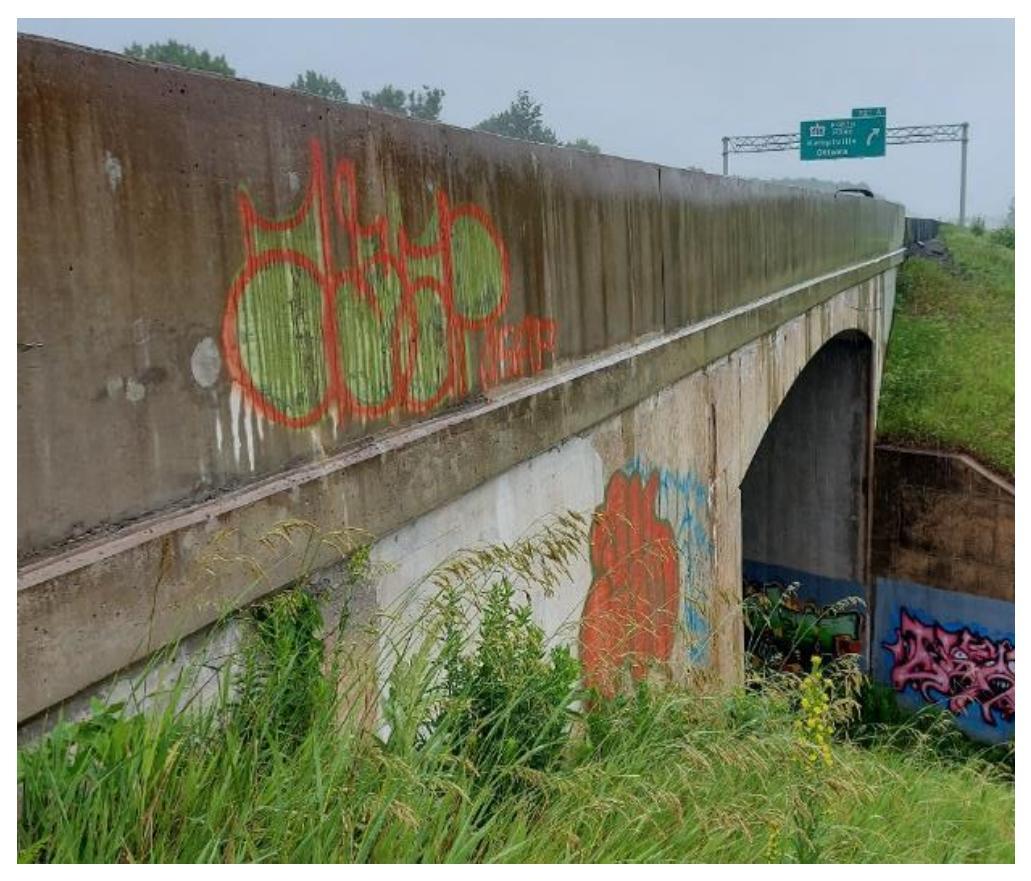
Photograph 24: Bridge No. 16-129 – Highway 401 CPR Overhead. View of the south side of the bridge with no date stamp present.

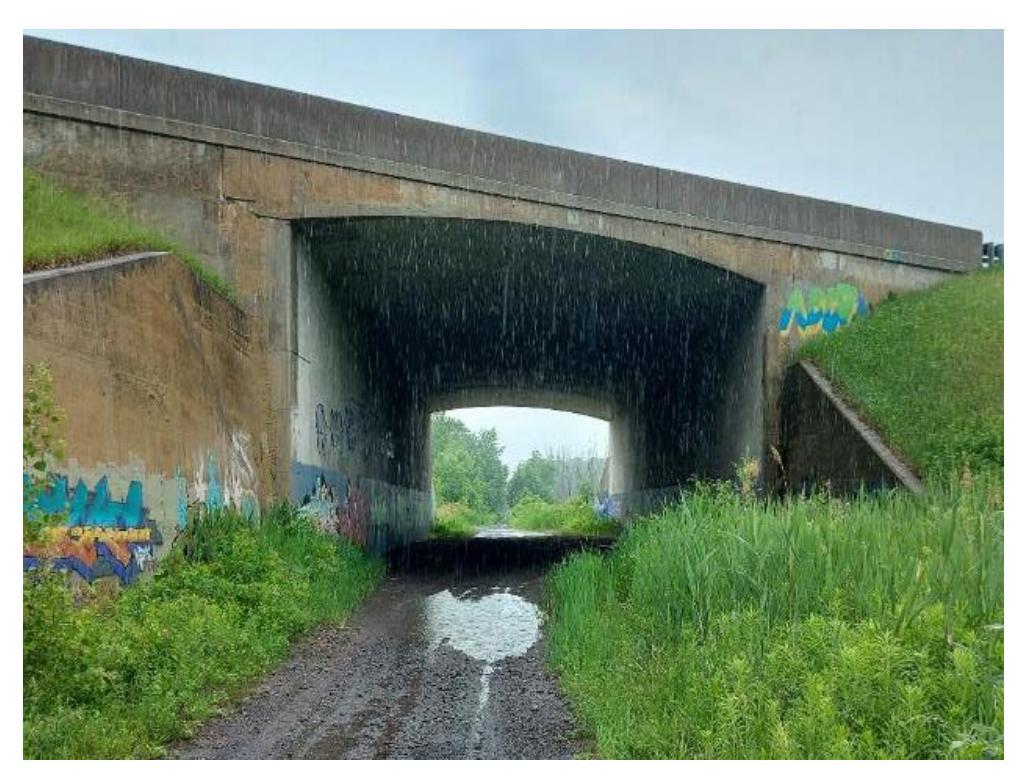
Photograph 25: Bridge No. 16-129 – Highway 401 CPR Overhead. General view of underside of the bridge along former CNR right of way.

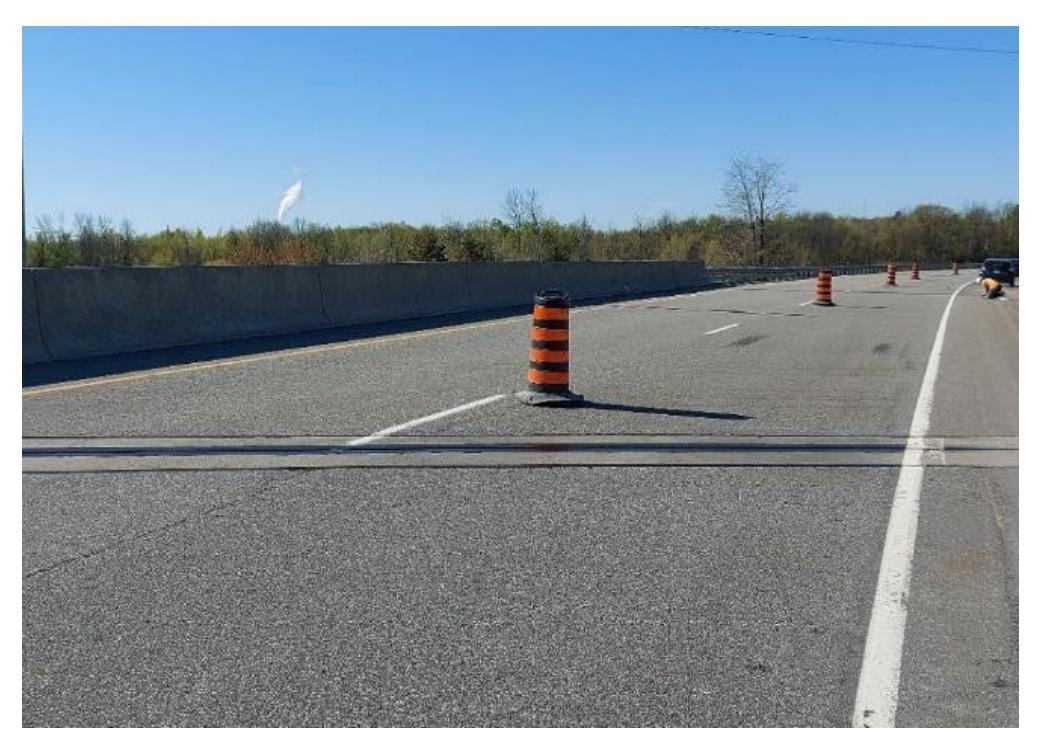
Photograph 27: Bridge No. 16-307 – Highway 401 Cedar Grove Road Overpass. General view looking south along the bridge.

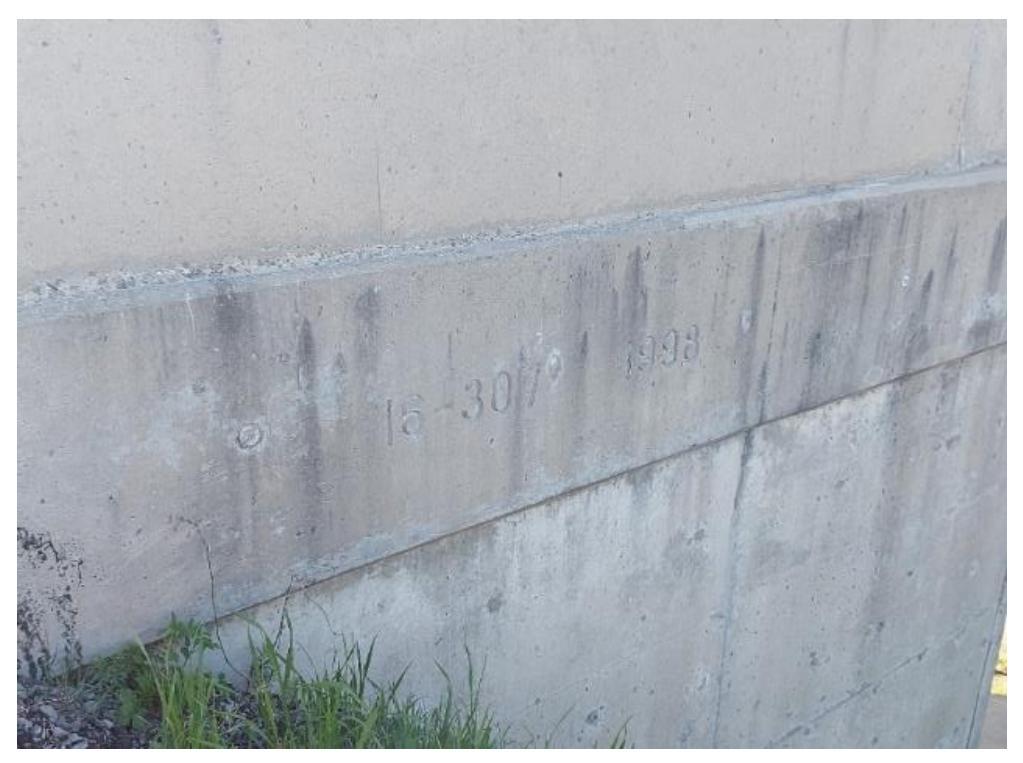
Photograph 28: Bridge No. 16-307 – Highway 401 Cedar Grove Road Overpass. View of bridge stamp with construction date along the west side of the bridge. Bridge stamped 16-307-1998.

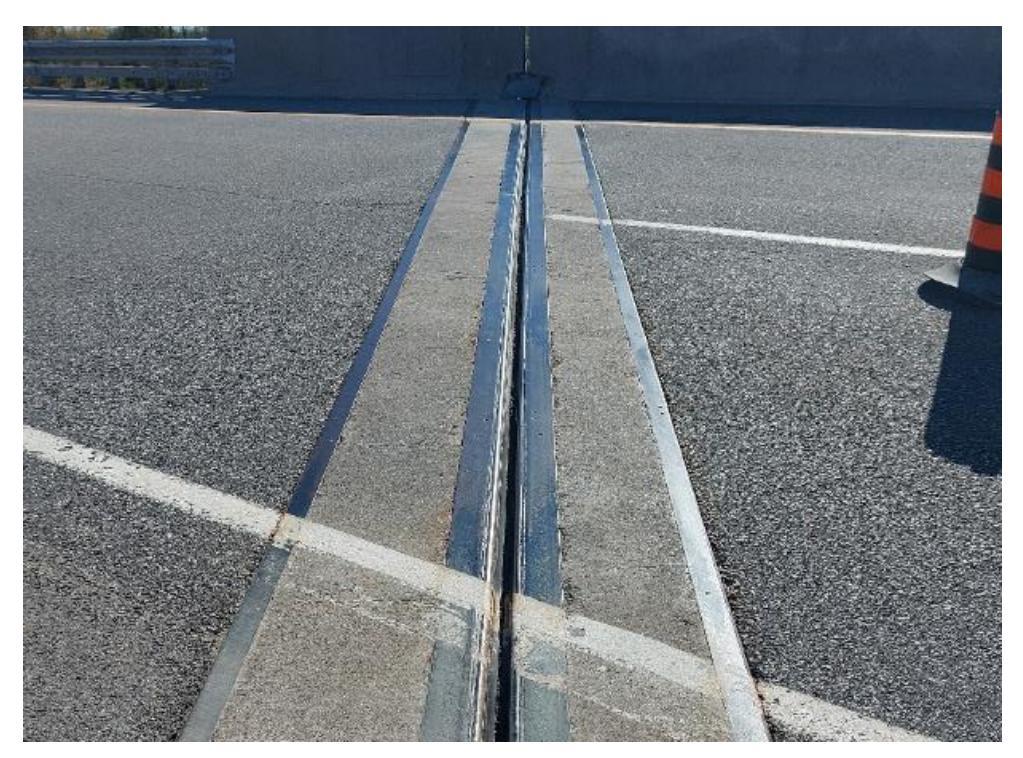
Photograph 29: Bridge No. 16-307 – Highway 401 Cedar Grove Road Overpass. View of a bridge deck expansion joint along the north side of the bridge.

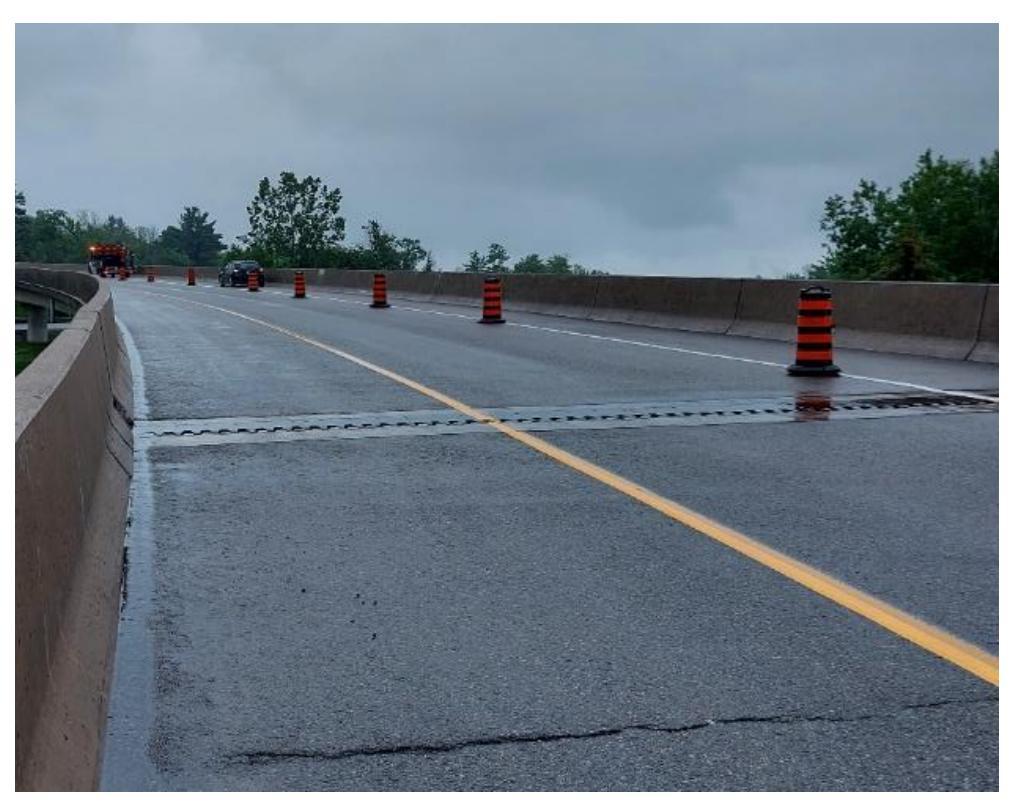
Photograph 32: Bridge No. 16-308 – Highway 401 Southbound Connector N-E. General view looking south along the bridge.

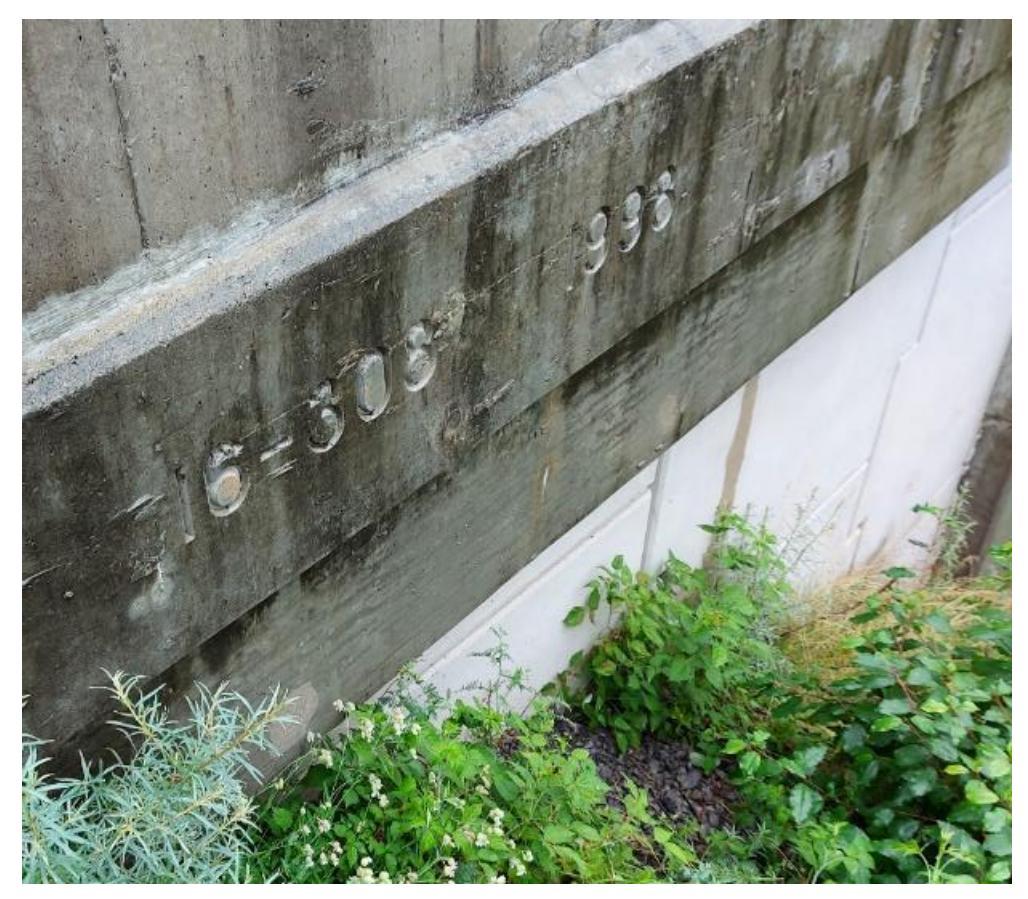
Photograph 33: Bridge No. 16-308 – Highway 401 Southbound Connector N-E. View of bridge stamp with construction date along the east side of the bridge. Bridge stamped 16-308-1998.

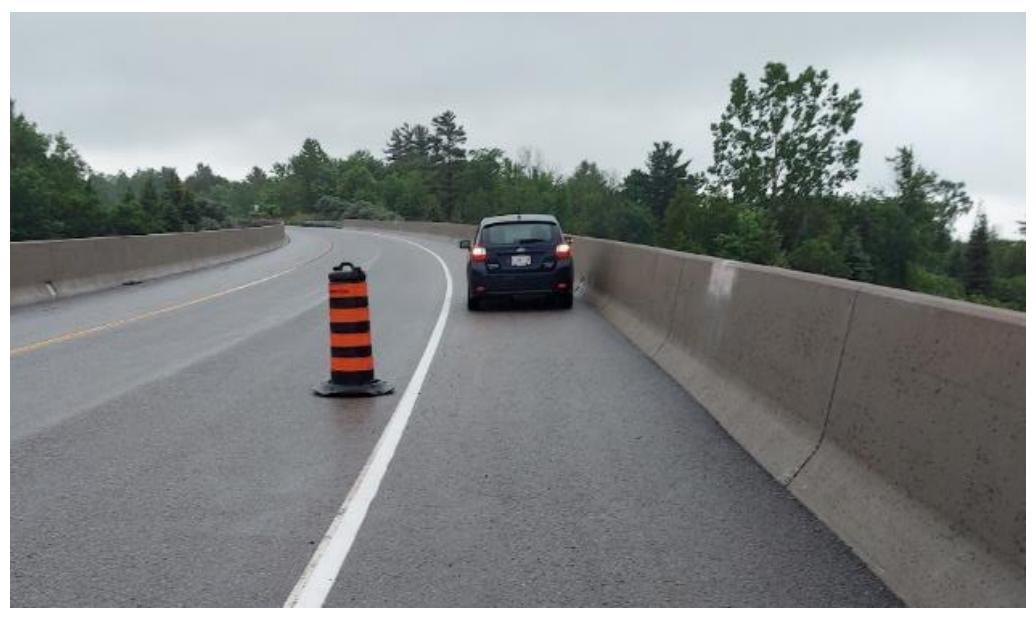
Photograph 34: Bridge No. 16-308 – Highway 401 Southbound Connector N-E. View of concrete barrier wall along The east side of the bridge.

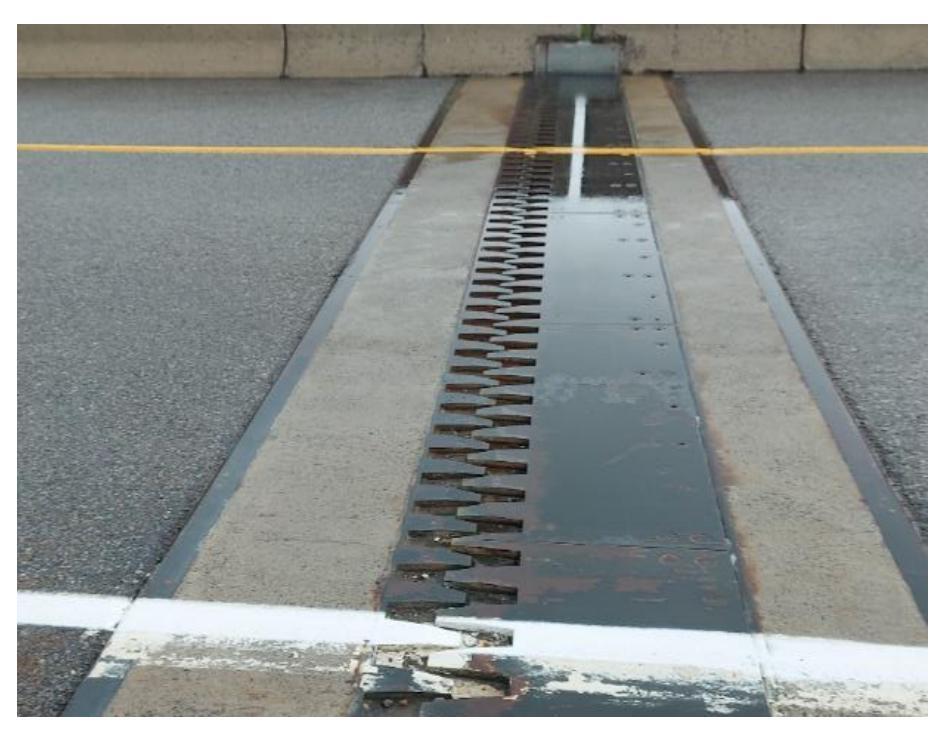
Photograph 35: Bridge No. 16-308 – Highway 401 Southbound Connector N-E. View of bridge deck expansion joint along the north side of the bridge.

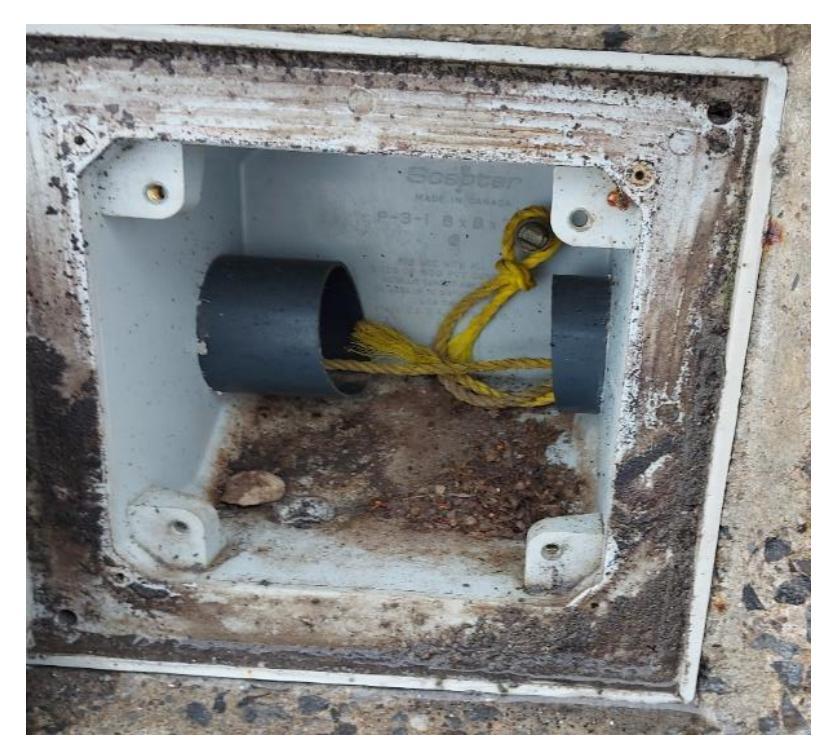
Photograph 36: Bridge No. 16-308 – Highway 401 Southbound Connector N-E. View of conduit hatch with PVC piping along the east side of the bridge. The hatch did not contain any electrical wiring. Rehabilitation of Ten Bridges and
