Designated Substance Survey

Highway 401 Improvements From 1 km East of Highway 16 to 3.3 km West of Maitland Road, Preliminary Design and Class Environmental Assessment Study – G.W.P. 4024-20-00

Ministry of Transportation, Eastern Region, Ontario

May 2022

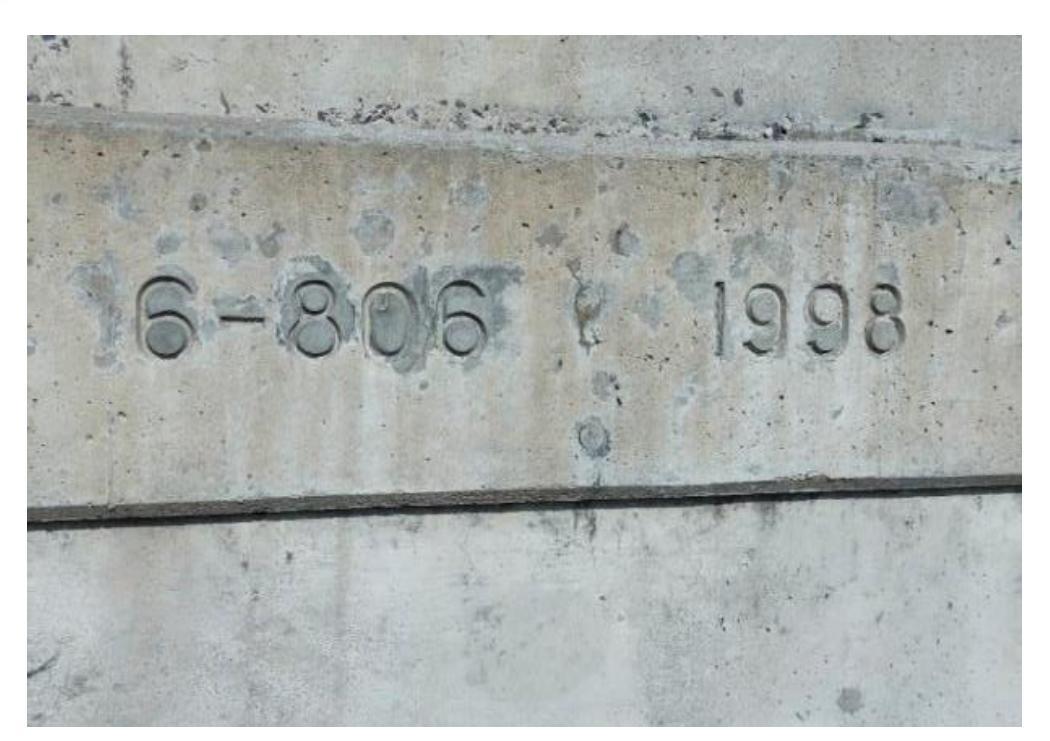
Photograph 39: Bridge No. 16-306 - Highway 401/416 W-N Ramp. View of bridge stamp with construction date along the east side of the bridge. Bridge stamped 6-806-1998.

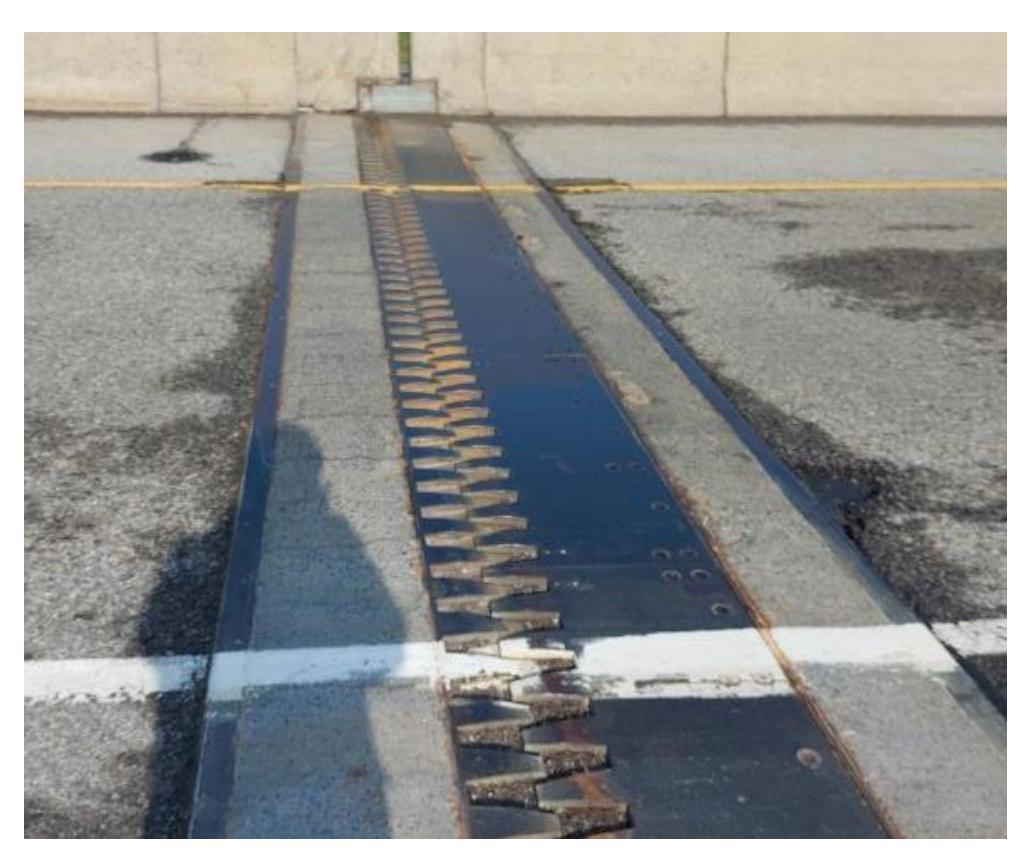
Photograph 40: Bridge No. 16-306 - Highway 401/416 W-N Ramp. View of bridge deck expansion joint along the north side of the bridge.

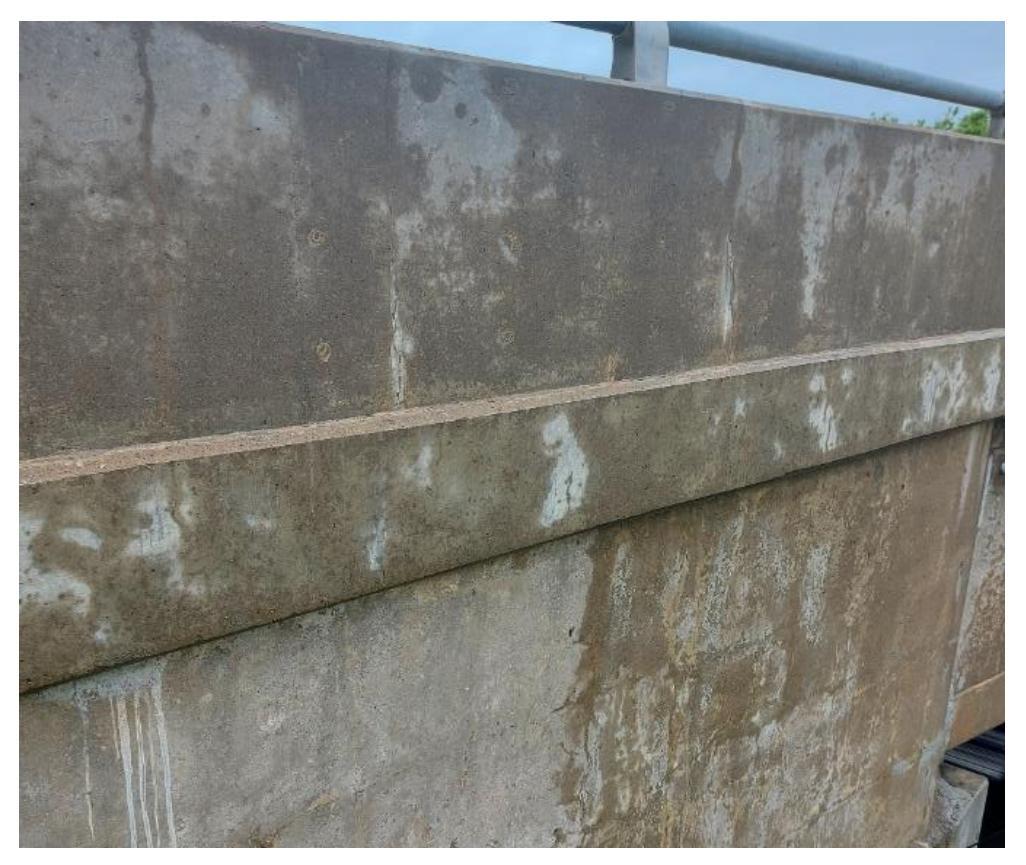
Photograph 44: Bridge No. 16-130-Highway 16 U/P. View of west side of bridge with no date stamp present.

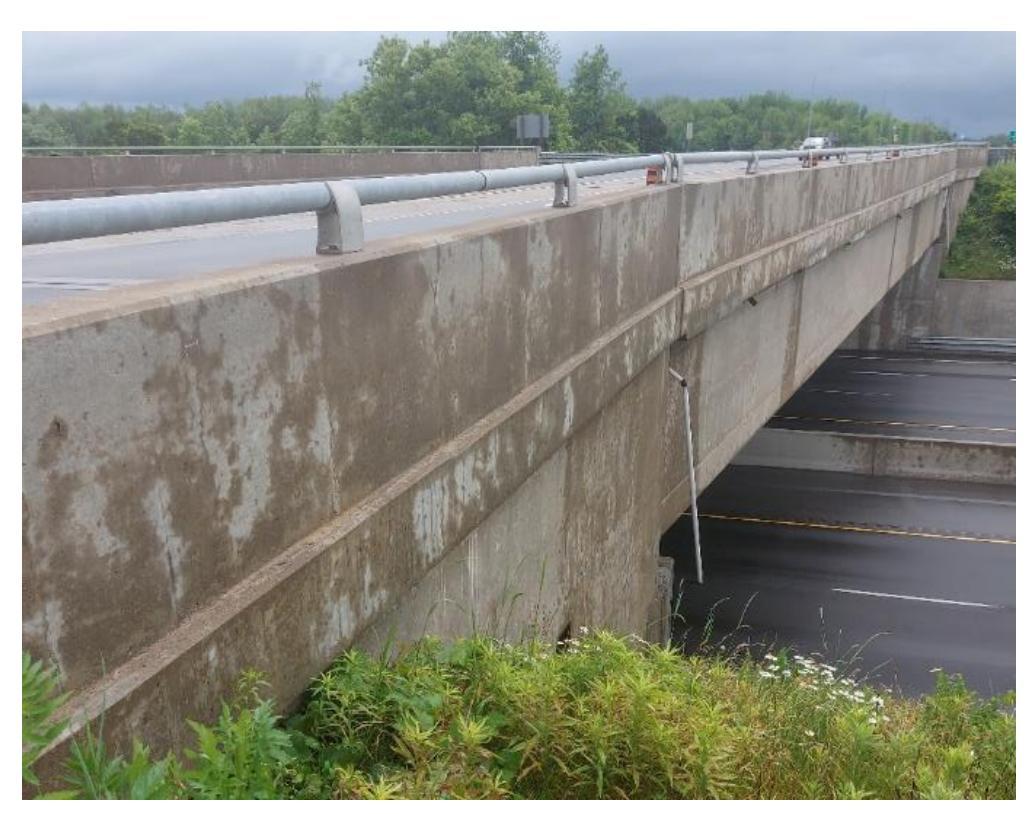
Photograph 45: Bridge No. 16-130-Highway 16 U/P. View of concrete barrier wall along west side of bridge with single tube metal railing.

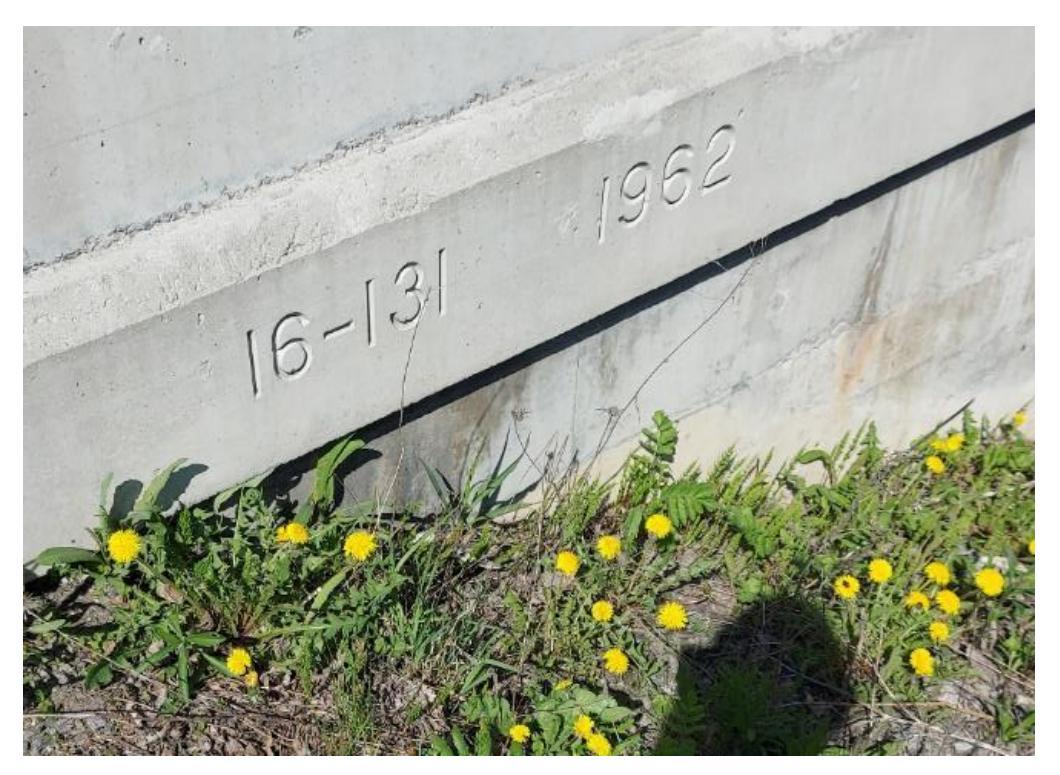
Photograph 48: Bridge No. 16-131 – Highway 16 CNR Overhead. View of bridge stamp with construction date along the east side of the bridge. Bridge stamped 16-131-1962.

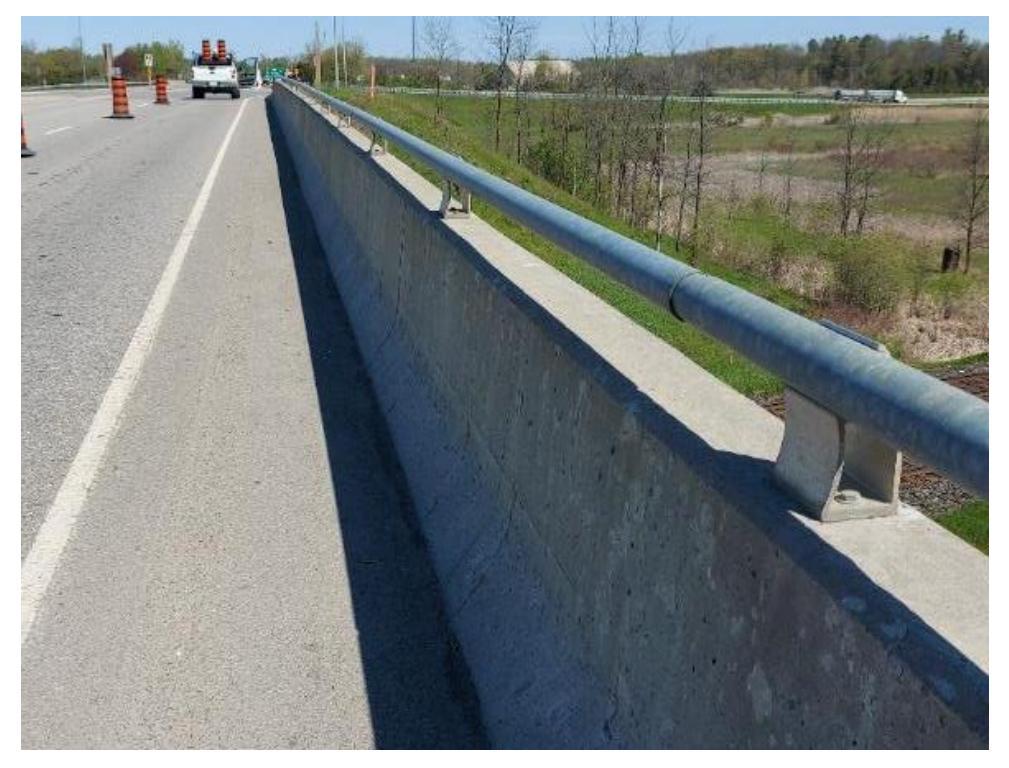
Photograph 50: Bridge No. 16-131 – Highway 16 CNR Overhead. View of concrete barrier wall along the east side of the bridge.

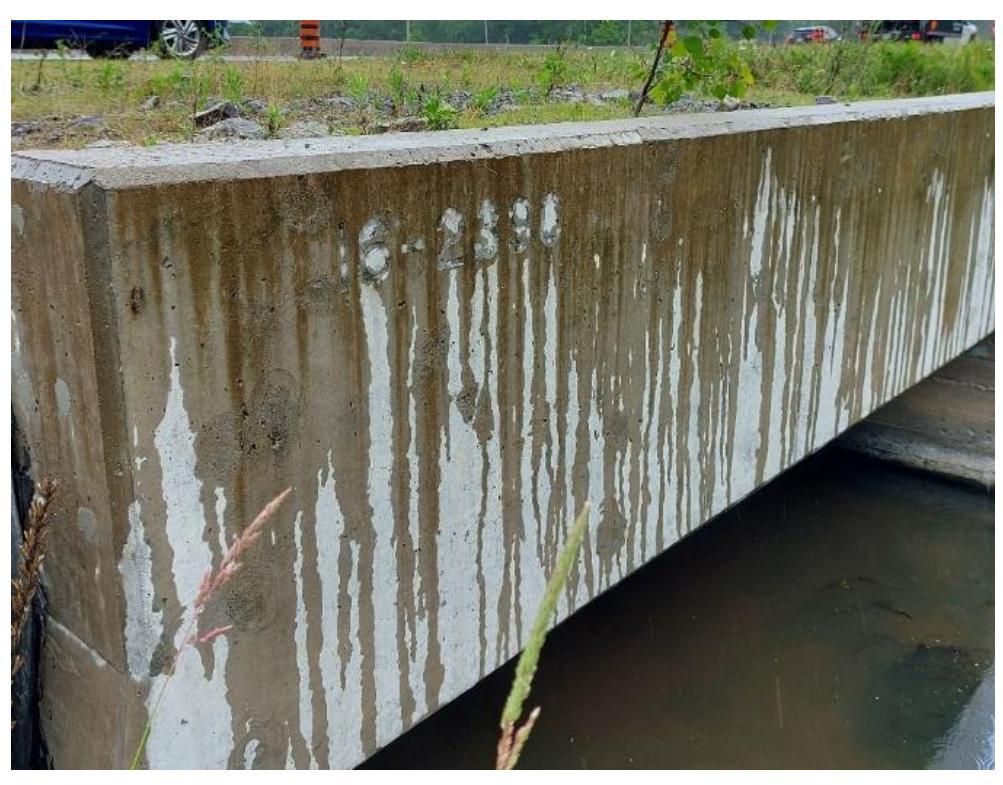
Photograph 53: Structural Culvert 16-239/C – Highway 401 Lemmon's Creek Culvert. View of culvert stamp with construction date along the east side of the culvert. Culvert stamped 16-239C.

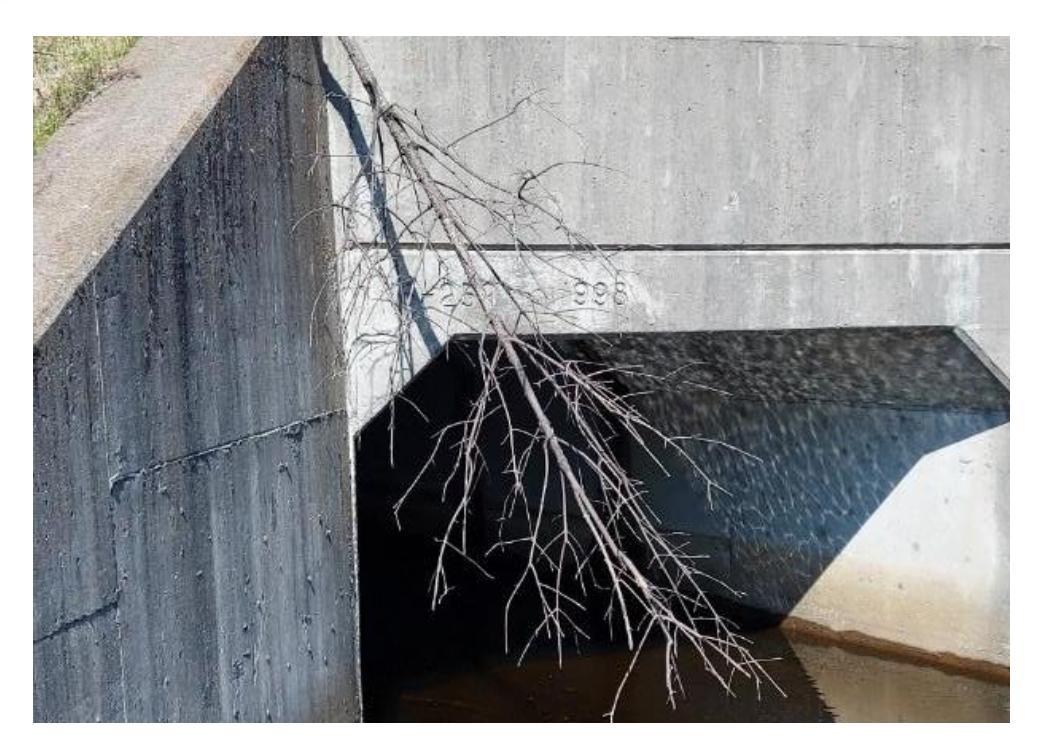
Photograph 57: Structural Culvert 16-259/C – Highway 401 W-416N Ramp Culvert. View of culvert stamp with construction date along the east side of the culvert. Culvert stamped 16-259-1998.

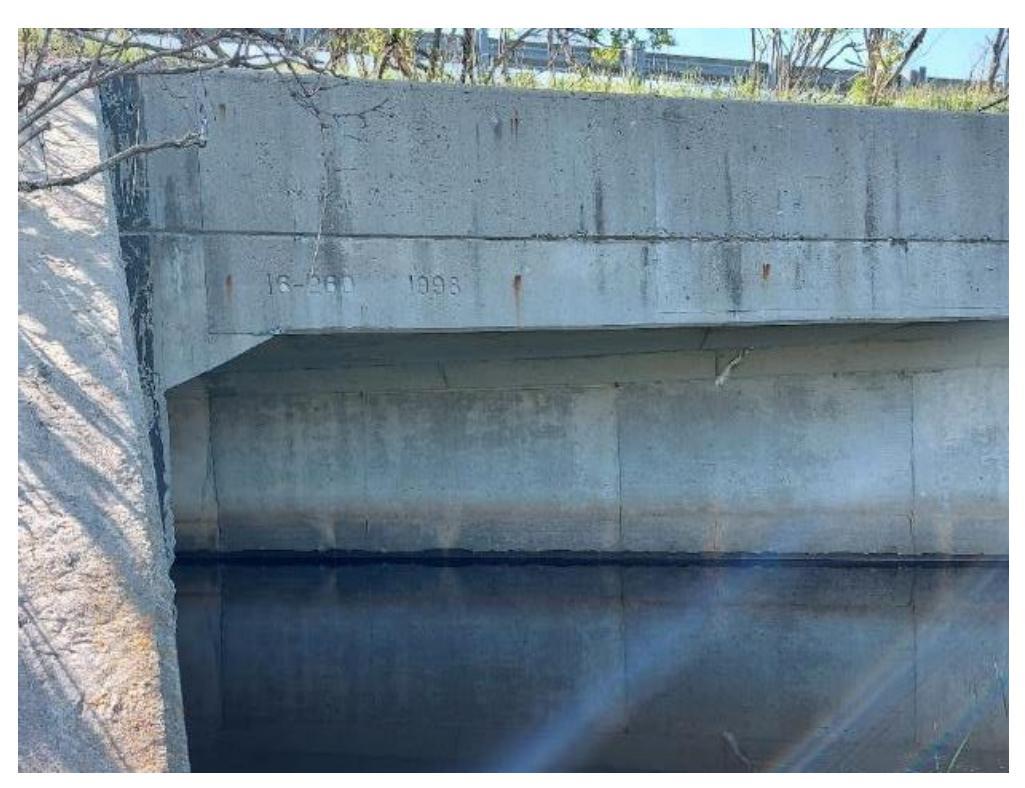
Photograph 59: Structural Culvert 16-260/C – Highway 401 W-401W Ramp Culvert. General view of structural culvert along the south side Highway 416 south abutment. Culvert stamped 16-260-1998.

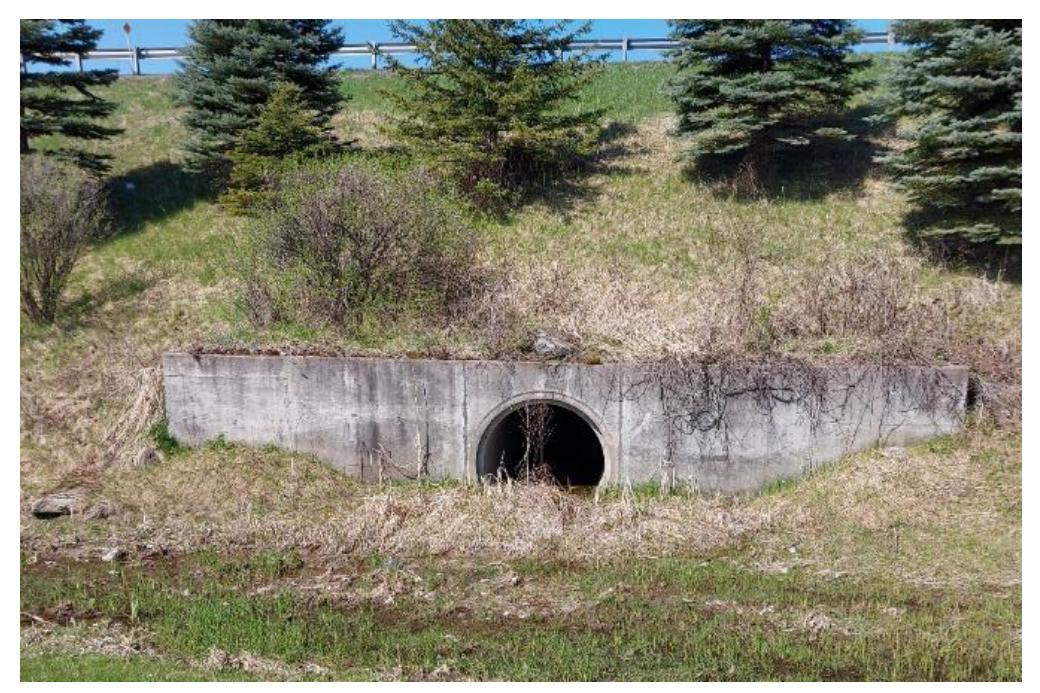
Photograph 62: Additional culvert at Project Site: View of additional culvert located along the south side of Highway 416 north abutment immediately north of bridge Site 16-307. Culvert was not stamped with any identification or construction date.
Ministry of Transportation, Eastern Region, Ontario
